NUMBER: 09-004-21

Oil Control Valve Connector Not Seated

2021 (DX) RAM Truck (Mexico)

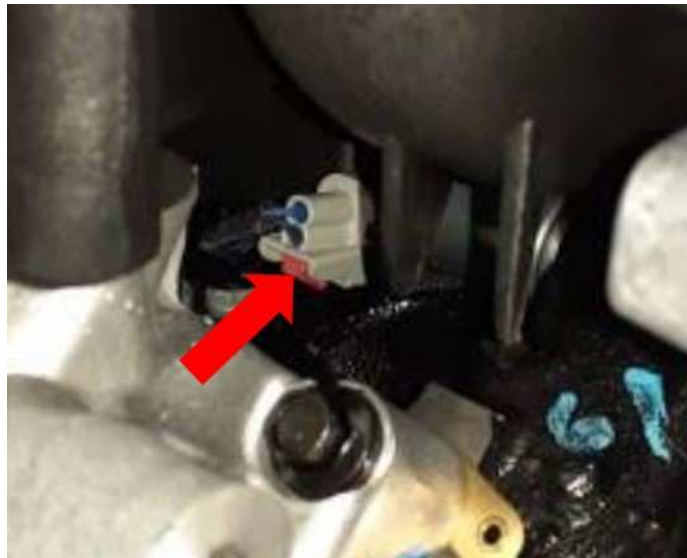
Fig. 4
Oil Control Valve Connector Red Secondary Lock

Customers may experience a Malfunction Indicator Lamp (MIL) illumination. Upon further investigation the technician may find the following Diagnostic Trouble Code (DTC) has been set:

- P0013 - Bank 1 Camshaft 2 Position Actuator Circuit Open.

9. Is the oil control valve connector red secondary lock (Fig. 4) engaged?
 - YES>>> Proceed to Step 11.
 - NO>>> Proceed to Step 10.
10. Using a pick tool (Fig. 3) or equivalent, perform a **push/pull/push test** on the connector and seat the red secondary connector lock (Fig. 4) .
11. Install the engine cover.
12. Push the air cleaner housing assembly straight downward to engage it on the grommets (Fig. 2) .
13. Connect the make up air hose (Fig. 2) on the air cleaner housing.
14. Install the clean air tube on the throttle body.
15. Connect the IAT sensor electrical connector.
16. Connect the negative battery cable.
17. Clear all DTCs that may have been set.
18. Close the hood.
