NUMBER: 09-005-21

6.2L Engine Oil Temperature Sensor Leak

RAM 1500 Pickup

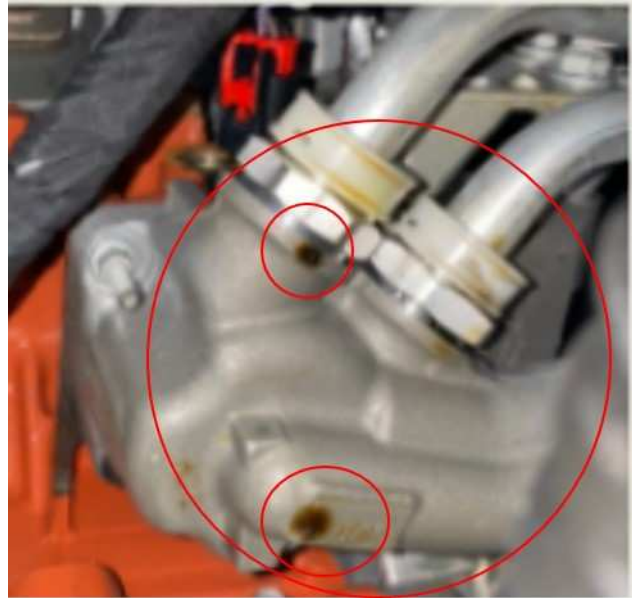
Customers may notice a slight oil leak from under the vehicle near the oil temperature sensor location (Fig. 1) .

Fig. 1
Oil Leaking/Dripping Location

2. Disconnect engine wire harness clips to gain access to the sensor wire harness.
3. Disconnect the oil temperature sensor wire harness connector.
4. Torque the oil temperature sensor to 50 N·m (38 ft.lbs). **Do not remove the sensor only torque to the specification provided in this step.**
