NUMBER: 09-007-21

6.2L Engine Oil Temperature Sensor Leak

2021	(WK)	Jeep Grand Cherokee
2021	(WD)	Dodge Durango

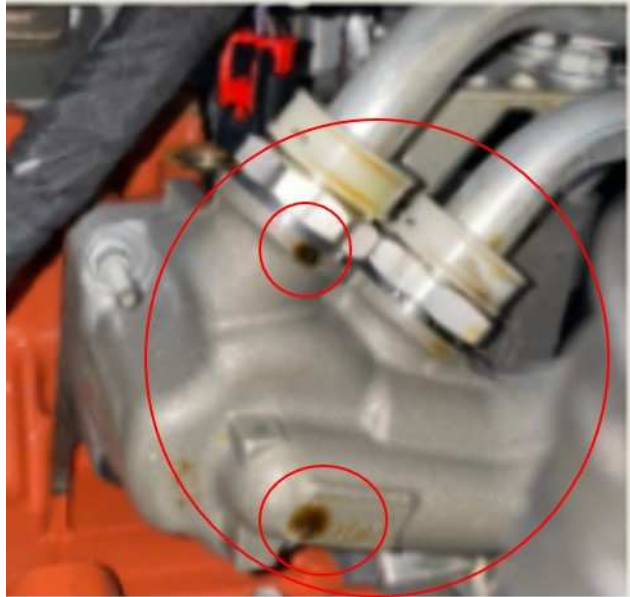
Customers may notice a slight oil leak from under the vehicle near the oil temperature sensor location (Fig. 1) .

Fig. 1
Oil Leaking/Dripping Location

This bulletin involves re-torquing the oil temperature sensor to specification.
