# Technical Service Bulletin

## 15 Oil leak from the cylinder head - 2.9 and 3.0TFSI only

15 21 39 2053278/8 June 25, 2021. Supersedes Technical Service Bulletin Group 15 number 21-38 dated April 1, 2021 for reasons listed below.

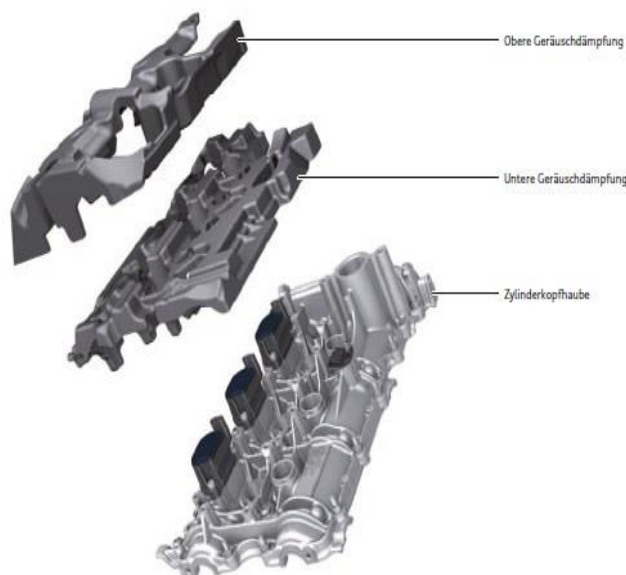
**Figure 1.** Removing the upper noise insulation.

2. Remove the upper noise insulation of the affected cylinder bank (Figure 1).

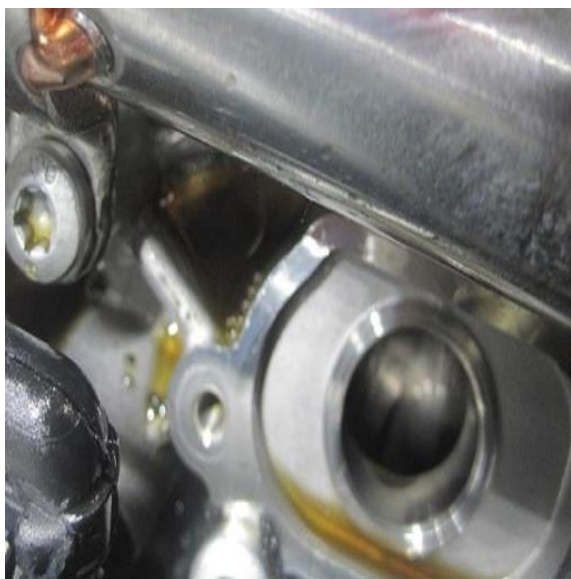
**A.** If there is a substantial quantity of oil below the Audi valvelift system actuator (illustration), the cause of the leak is the O ring of the Audi valvelift system actuator.

**Figure 2.** Oil in the Audi valve lift system.

Replace the Audi valvelift system actuator with an O ring, clean the engine compartment, and if necessary replace the noise

insulation (if it is soaked in oil)  
(Figure 2).

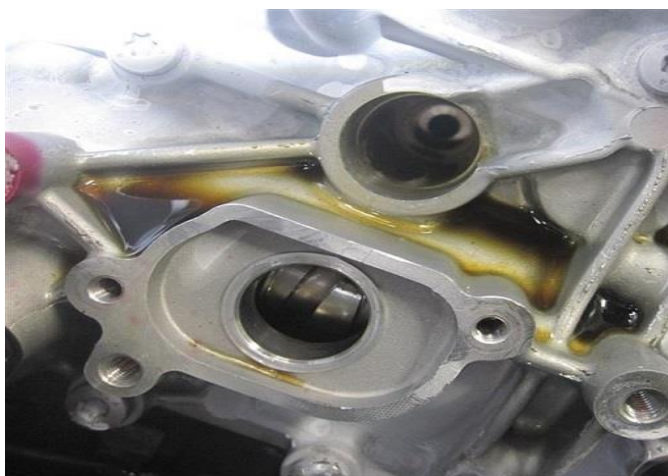
4. Remove the lower noise insulation.
5. Locate the affected cylinder. Oil  
should have gathered in the area of  
the injector (Figure 3) and the noise  
insulation should also be soaked in  
oil.

**Figure 3.** Locating the affected cylinder.

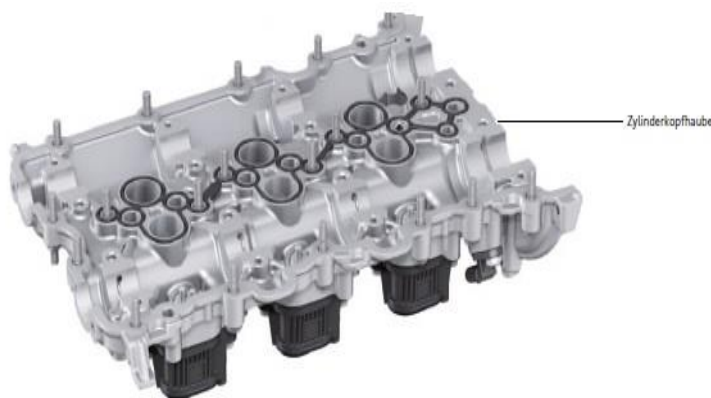
**Figure 4.** Remove the cylinder head cover and gasket.

6. Remove the cylinder head cover and  
the seal (Figure 4).

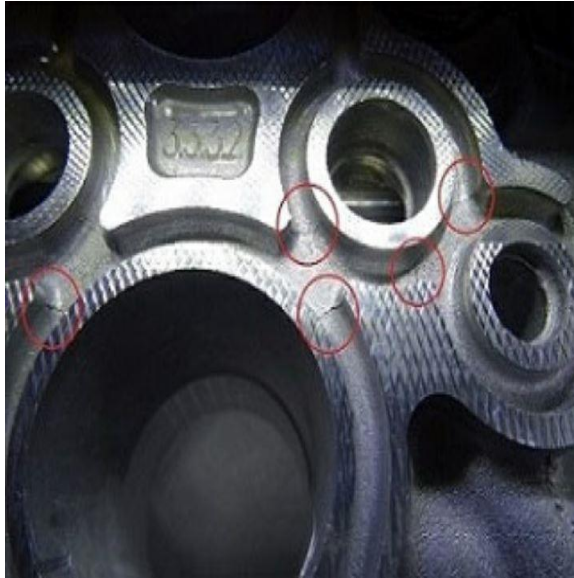
Metal shavings produced during manufacture in sealing groove between cylinder head cover and the cylinder head.

*Figure 5. Before the repair.*

7. Inspect the gasket groove in the cylinder head cover and remove any casting residues with a suitable tool (Figure 5). The residues can be removed with a small flat screwdriver (Figure 6).

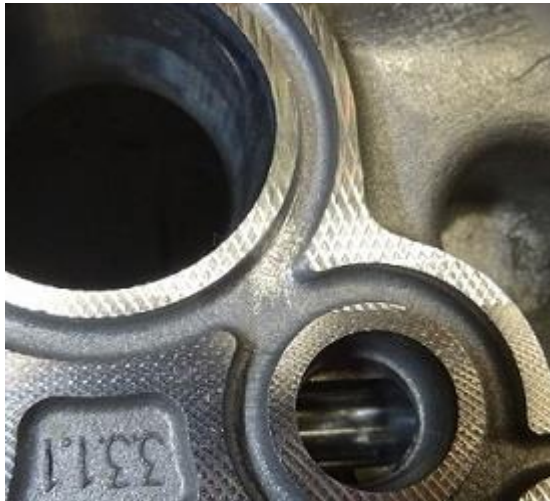
*Figure 6. After the repair.*

8. Install a new seal, re-assemble the camshaft cover, clean the engine compartment, and if necessary replace the noise insulation (if it is full of oil).
