Technical Service Bulletin

GRINDING NOISE FROM REAR BRAKES

Bulletin No.: 04-002/21

Last Issued : 06/04/2021

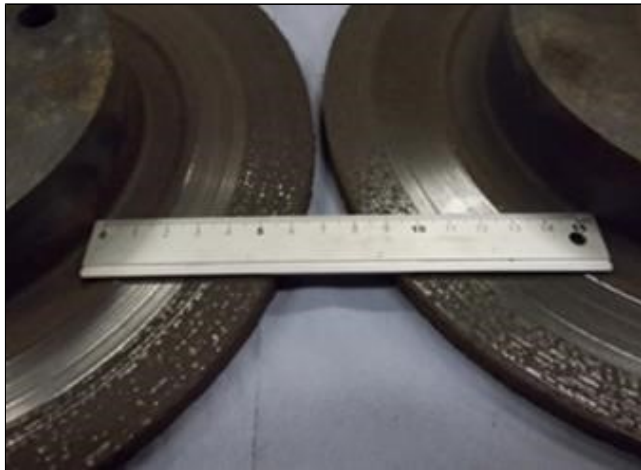
Outer Side

Some vehicles equipped with electric parking brake (EPB) may exhibit a grinding noise from the rear brakes when braking. This may be caused by the rear brake pads not having the capability to remove the rust from the rear brake discs. The red rust accumulated on the discs is exposed to high temperatures during braking, and consequently the rust turns black. As the black rust is too hard to be removed by the brake pads, the rust progress is accelerated, resulting in the grinding noise.

To eliminate this concern, the brake pad material has been changed in order to improve the rust-removing capability.

1. Verify the customer concern.
2. Replace the rear brake pads with modified ones according to MGSS online:
 - CX-3: REAR BRAKE DISC PAD REMOVAL/INSTALLATION
 - CX-5: REAR BRAKE DISC PAD REMOVAL/INSTALLATION
 - CX-9: REAR BRAKE DISC PAD REMOVAL/INSTALLATION
 - Mazda6: REAR BRAKE DISC PAD REMOVAL/INSTALLATION
3. Replace the rear disc plates with new ones according to the MGSS online:
 - CX-3: REAR BRAKE DISC REMOVAL/INSTALLATION
 - CX-5: REAR BRAKE DISC REMOVAL/INSTALLATION
 - CX-9: REAR BRAKE DISC REMOVAL/INSTALLATION
 - Mazda6: REAR BRAKE DISC REMOVAL/INSTALLATION
