Technical Service Bulletin

MAZDA CONNECT REBOOTS OR SCREEN TURNS BLACK

Bulletin No.: 09-017/21

Last Issued : 06/02/2021

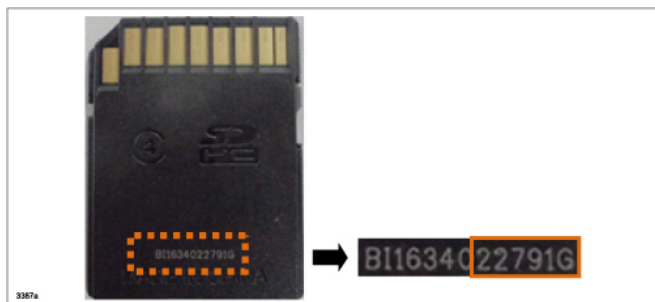
2. Remove the SD card and check the last 6 digits of the lot number on the SD card.

- If the SD card has any of the following 6 digit lot numbers, replace it with a new SD card.

50424D	50631D	50635G	50881G	50955G
50428G	50632G	50877D	50913D	50995G

NOTE: The new SD card has a capacity of 16 GB, not 8 GB, like the original.
