| <b>Subject:</b><br><br><b>FUEL-FILLER LID PANEL IS DEFORMED</b> | <b>Bulletin No.:</b> 09-019/21 |
| | <b>Last Issued :</b> 06/24/2021 |

2019-2021 Mazda3  
2020-2021 CX-30

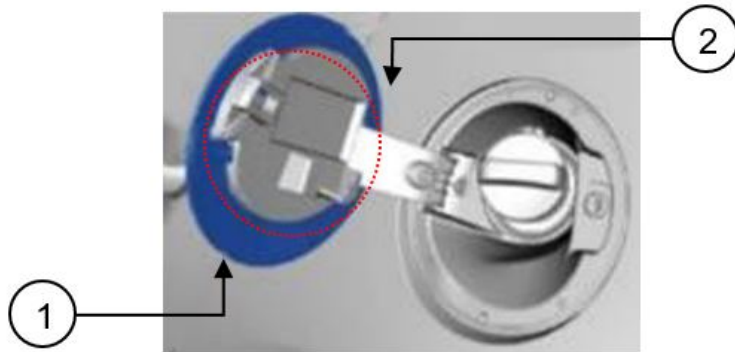
Some vehicles may exhibit a deformed fuel-filler lid panel (1) attached to the fuel-filler lid box, resulting in a poor appearance.

This concern is caused by the lid box not having enough water drainage capability which leads to the accumulation of water inside it. The water then freezes in cold weather and expands or the inner side of the lid panel absorbs the water and swells from long exposure, deforming the lid panel. To eliminate this concern, the shape of the fuel-filler lid box has been modified to have better drainage capability and a modified fuel-filler lid panel service part has been established for less water absorbance.

1. Verify customer concern.
2. Replace the fuel-filler lid panel (1) with a modified one according to the instructions on MGSS.
  - Mazda3 (FUEL-FILLER LID REMOVAL/INSTALLATION)
  - CX-30 (FUEL-FILLER LID REMOVAL/INSTALLATION)
