EXTERIOR TRIM HEAT DAMAGE

M-Tips No.: MT-003/21

Last Issued : 06/01/2021

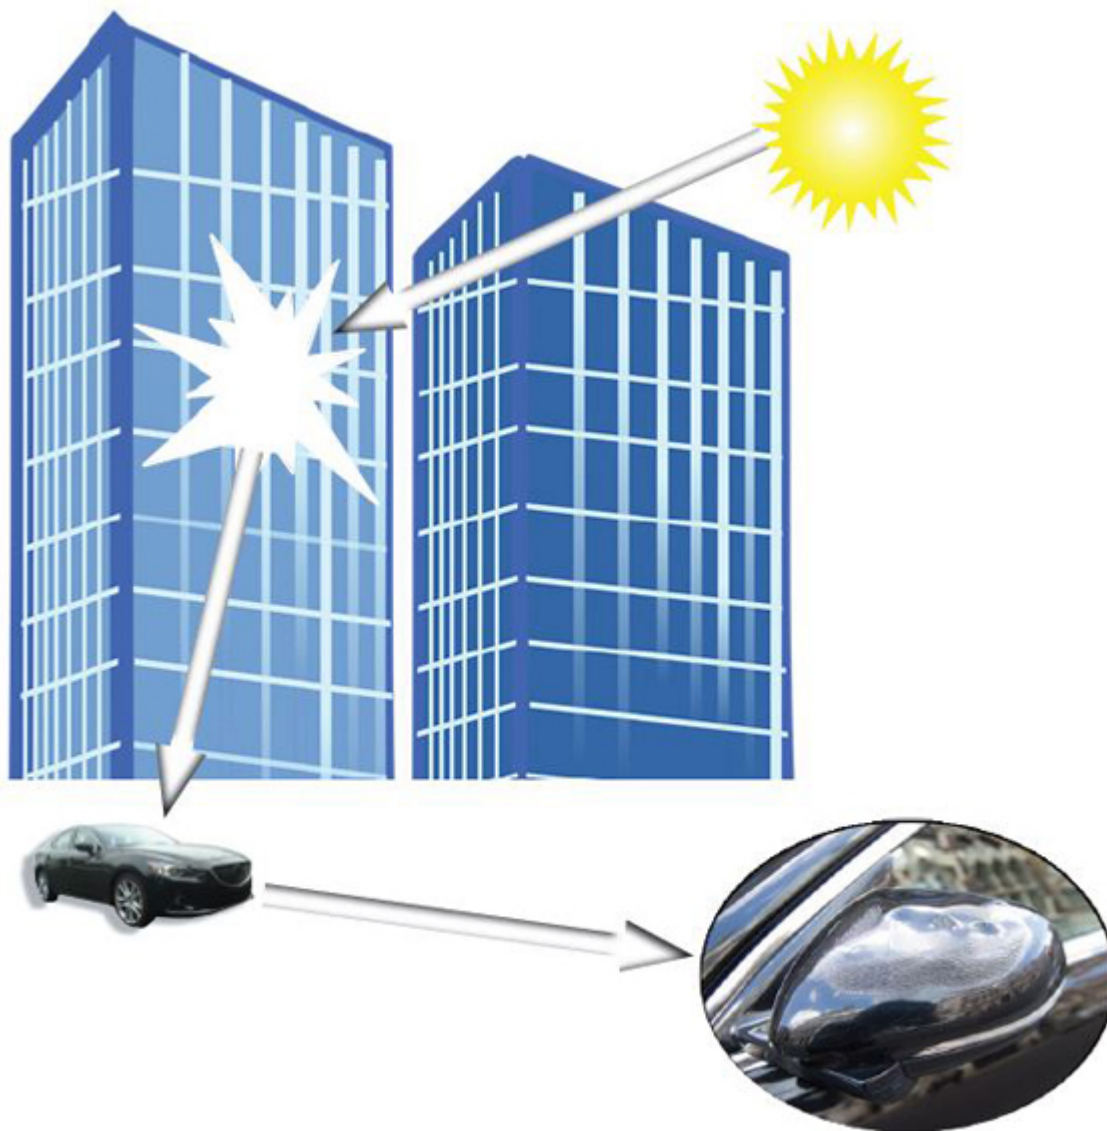
Some vehicles may experience exterior trim heat damage when parked near a glass building. This may be caused by the sun's reflection.

If a building creates enough of a curve with a series of flat windows, which act like mirrors, the reflections all converge at one point, focusing and concentrating the light onto the street below.

Vehicle repairs for this concern are not covered under Mazda's warranty policy.
