01-18-13 - MIL ON DTC P0401 Exhaust Gas Recirculation Flow Insufficient

Release date: 6/29/2021

High soot loads prior to regeneration can cause possible restrictions in the Exhaust Gas Recirculation (EGR) filter.

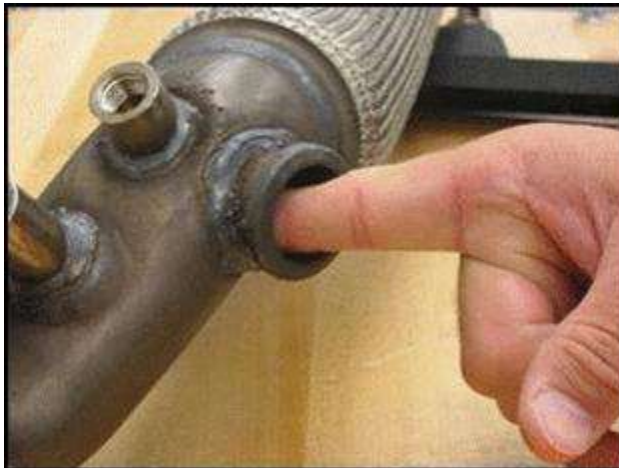
Figure 1

- Remove the EGR filter from the Diesel Particulate Filter (DPF) and swipe the inside of the exhaust pipe at the EGR filter connection point using a clean cloth or your finger. See figures 1 and 2 below.

If your finger or the cloth comes out with black soot:

- Replace the DPF & EGR filter together.
- Smoke test the charge air system for leaks (see procedure below).
