SS 709-WST 2021 Fuel Sending Unit Connector Loose

49X builds.

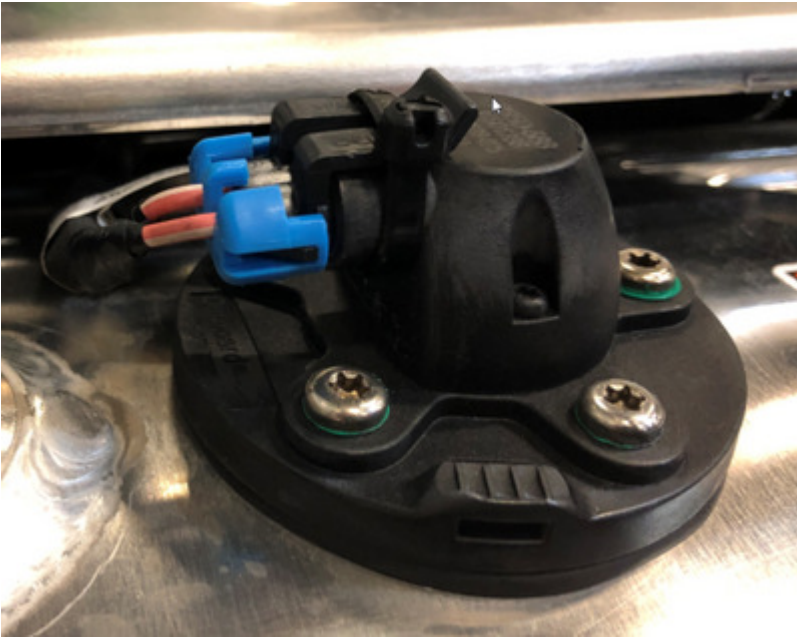
Fuel distribution from tank may be affected.

Fuel sending connector detached/unplugged.

Tie strap fuel sending unit on the plug locking tab to prevent disconnection.
