# TECHNICAL SERVICE BULLETIN

## Turn Signal Lamps Inoperative After LED Control Module Replacement

**21-2195**  
28 June 2021

Ford 2020-2021 Explorer
----------------------------

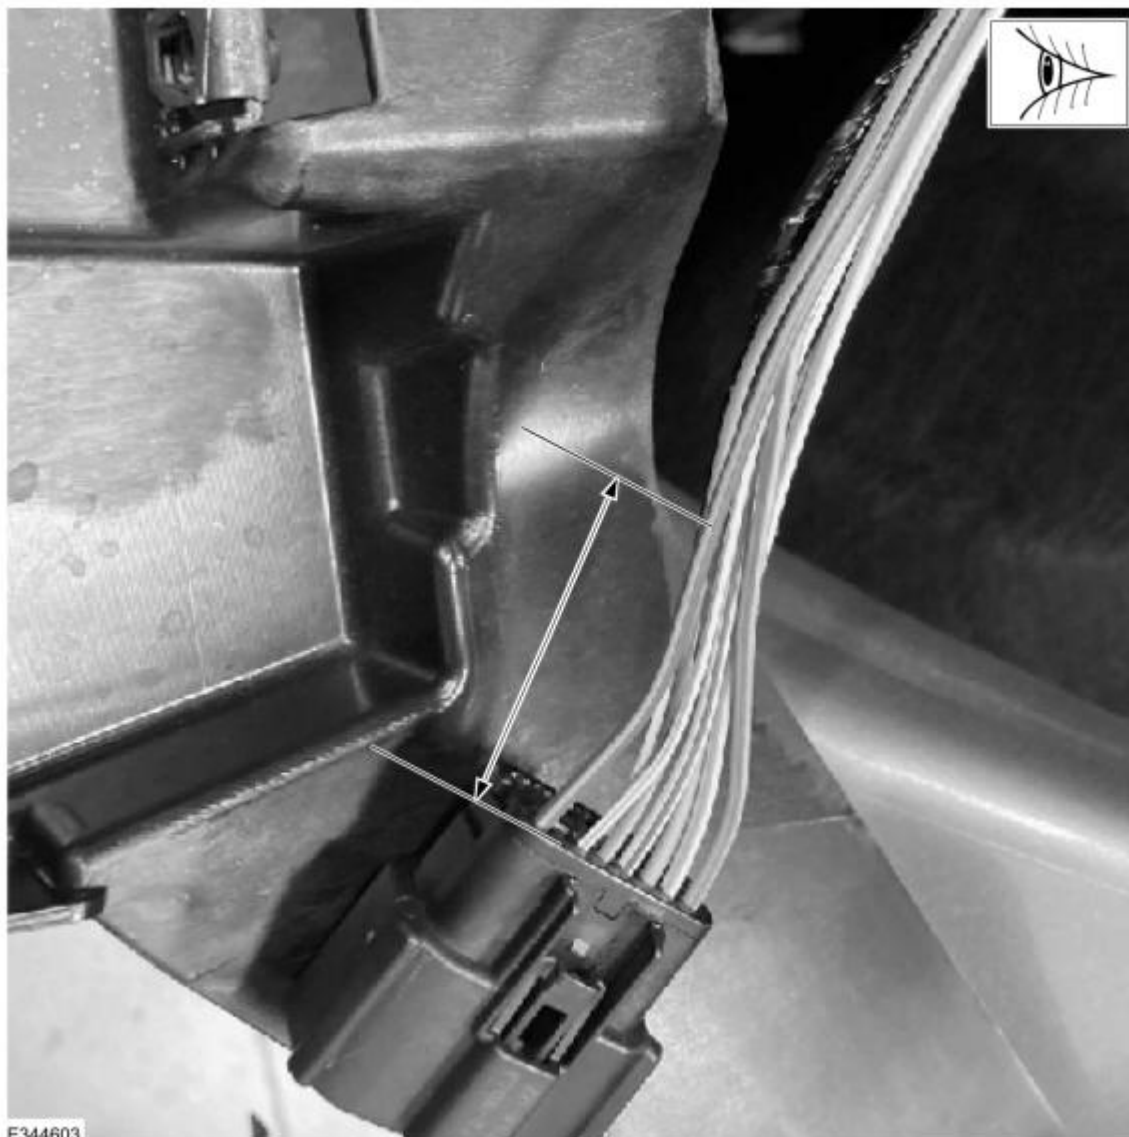
Figure 1 - Left side

**Issue:** Some 2020-2021 Police Interceptor Utility vehicles may exhibit inoperative turn signal lamps after replacement of the light emitting diode (LED) control module. This may be due to a lack of initialization caused by incomplete wiring circuits. To correct the condition, follow the Service Procedure to splice the needed circuits into the wiring harness of the affected side of the vehicle.

1. Remove the affected headlamp assembly. Refer to Workshop Manual (WSM), Section 417-01.
2. For vehicles where the left side is affected, update the left side wiring.
  - (1). Remove 2 wiring terminals from the wiring service pigtail connector.

- (2). Install the terminals into connector C1284, pins 9 and 14. Refer to Wiring Diagram, Cell 085-4.
- (3). Cut the wire to circuit GD120, pin 8 on connector C1284, 76.2 mm (3 in.) from the connector.
- (4). Solder splice wires from pins 8, 9, and 14 to circuit GD120. Refer to Wiring Diagram, Cell 005. (Figure 1)
