ROADSTER Accessory Port Power Supply Issue - Possible Inverted Wires at Vehicle Connector_138823

- Possible inverted wires at the vehicle accessory port
- Functionality issue with GPS support kit 219400992 and the LED Floorboard lights kit 219401038

YEAR	MODEL
2018 and newer	Spyder F3 T and F3 Limited
2020 and 2021 built before January 2021	Spyder RT Series

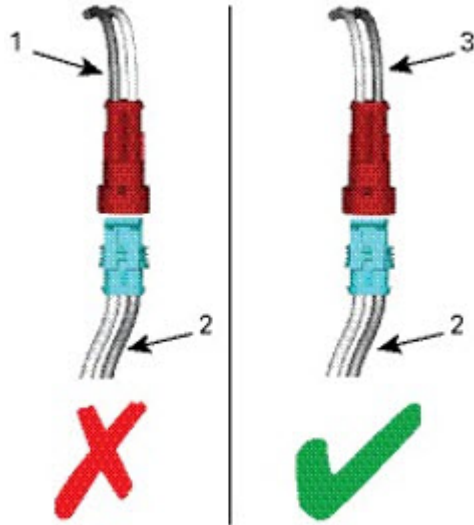
- 1. Black wire on female connector at the wrong location
- 2. Black wire on male connector
- 3. Black wire on female connector at the appropriate location

2. Make sure that the black wire on the male connector is on the same side as the female connector
