Technical Service Bulletin

90 Instrument cluster displays an incorrect vehicle model

90 21 08 2063859/1 June 30, 2021.

Model(s)	Year	VIN Range	Vehicle-Specific Equipment
RS 6	2021	900001 - 965524	Audi virtual cockpit

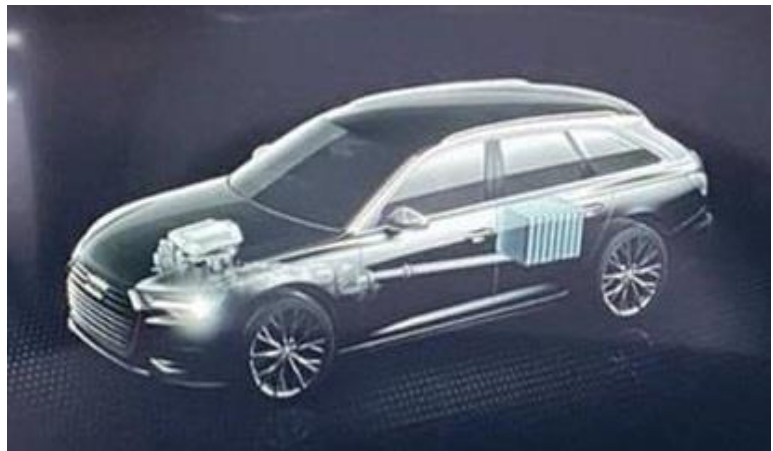
- The vehicle displayed on the sport design in the Audi virtual cockpit depicts a hybrid vehicle instead of an Audi RS 6 (Figure 1).

Figure 1. Hybrid vehicle is incorrectly displayed in the instrument cluster.

There is a software related malfunction in Audi virtual cockpit.

- Update the instrument cluster infotainment system using either Method 1 or Method 2 according to TSB 2060523: *91 MIB3 Software Update Instructions* and use SVM code **FPKWW0056**.

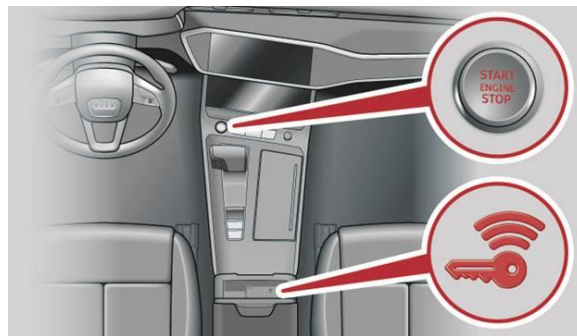
Figure 2. Key placement during flash process.

Please place the vehicle's key on the emergency key reader coil for the complete duration of the update. Otherwise, the update might fail (Figure 2).
