# Technical Service Bulletin

## 90 Instrument cluster driver information system display is blank

90 21 09 2063913/1 June 30, 2021.

Model(s)	Year	VIN Range	Vehicle-Specific Equipment
A4, A4 allroad, S4, A5, A5 Cabriolet, A5 Sportback, S5, S5 Cabriolet, S5 Sportback, RS 5, RS 5 Cabriolet, RS 5 Sportback, Q5, SQ5, Q5 PHEV, Q5 Sportback, and SQ5 Sportback	2021	All	Analogue instrument cluster

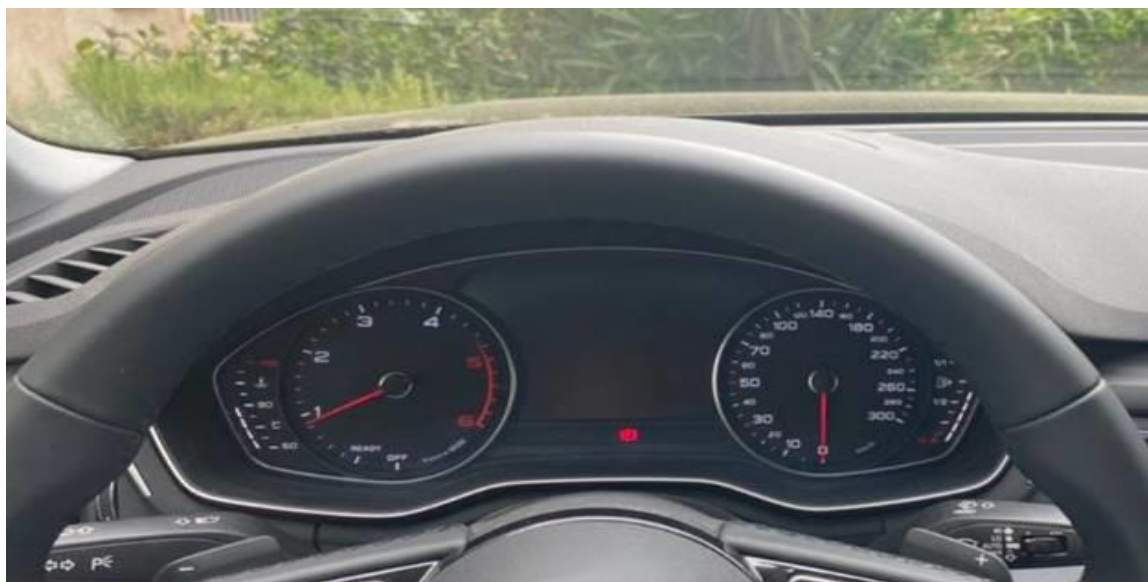
- The driver information system in the instrument cluster (PR Code 9S7) is blank.
- The speedometer, tachometer and bar graphs showing the fuel level and coolant temperature work normally (Figure 1).

**Figure 1.** Instrument cluster display is blank.

There is a hardware defect in the instrument cluster.

1. Follow all instructions in TSB 2011732: *00 Software Version Management (SVM), operating instructions*.
2. Update the instrument cluster, J285 (address word 0017) using the SVM action code as listed in the table below, if necessary:
