Technical Service Bulletin

91 MIB2+ Standard: the MMI screen is fuzzy, blurry or flickering

91 21 11 2061031/3 June 30, 2021. Supersedes Technical Service Bulletin Group 91 number 20-46 dated December 16, 2020 for reasons listed below.

Model(s)	Year	VIN Range	Vehicle-Specific Equipment
Q3	2019 - 2021	All	MIB2+ Standard

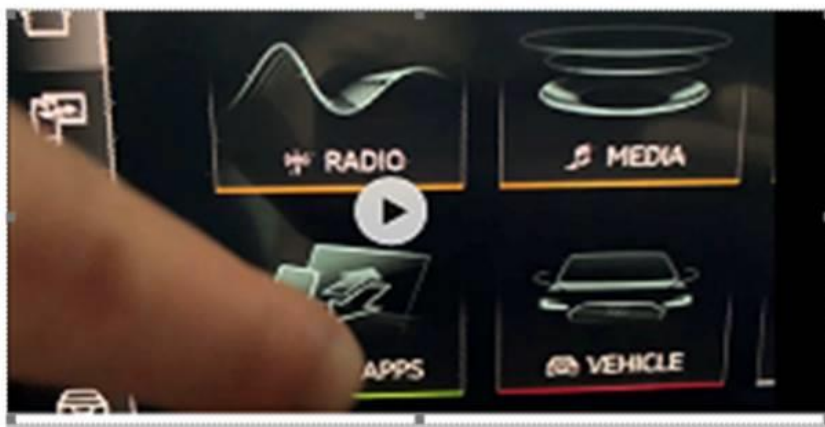
- The MMI screen picture appears fuzzy or blurry (Figure 1).

Figure 1. The MMI screen is fuzzy.

A software bug in the display driver can cause the screen to become permanently fuzzy.

1. Please take photos of the customer concern and upload them into DOC-IT with the repair order. Photos should:
 - Have a date stamp and VIN reference.
 - Be taken in focus and with sufficient light.
2. Replace the information electronics control module, J794 (address word 005F).

The software part number remains the same; only the software version changes: SW 2628 (old part) => SW 2632 (new part).
