Service Alert

Subject: i-ACTIVESENSE WARNING AND SBS INDICATOR LIGHTS ON WITH DTC B14F9:00 STORED UNDER HOT WEATHER CONDITIONS	Service Alert No.: SA-039/21
	Last Issued : 06/04/2021

2019-~~2021~~ Mazda3
2020-~~2021~~ CX-30

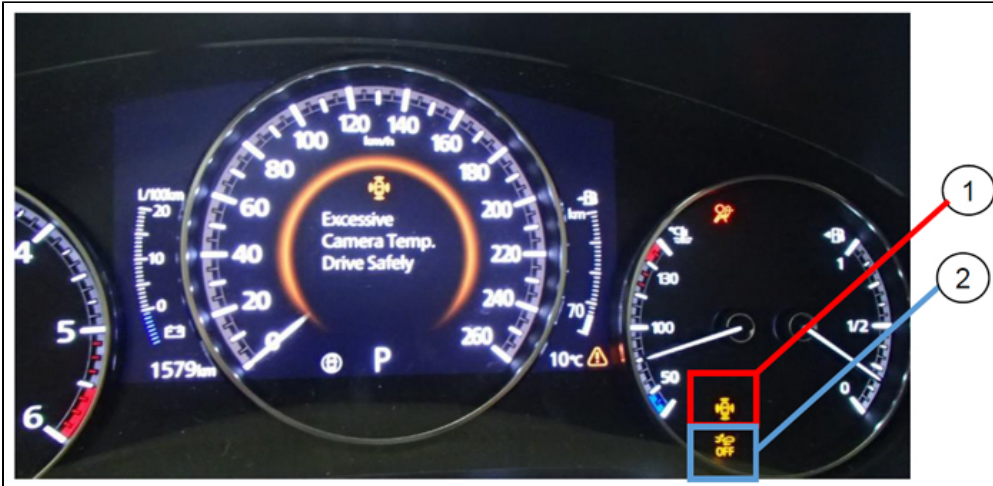
- i-ACTIVESENSE warning light ON (1)
- Smart Brake Support (SBS) indicator light ON (2)
- "Excessive Camera Temp. Drive Safely" or "Safety and Driver Support Systems Temporarily Disabled" warning messages
- DTC B14F9:00 stored in memory

DTC_B14F9:00 is falsely stored instead of DTC B14F0:4B.

DTC_B14F0:4B [VCM] (Forward sensing camera (FSC) internal temperature abnormality) - FSC detects temperature higher than operation range.

1. Verify customer concern.
2. Check for DTCs.

- **YES:** Go to MGSS DTC B14F0:4B [VEHICLE CONTROL MODULE]
- **NO:** This service information does not apply. Go to MGSS for normal diagnosis.

3. Contact Hotline for latest repair information.
4. Verify repair.
