# Service Alert

<b>Subject:</b>  <b>CONNECTED VEHICLE SYMPTOM TROUBLESHOOTING</b>	<b>Service Alert No.:</b> SA-013/21
	<b>Last Issued :</b> 06/02/2021

2019-2021 Mazda3  
2020-2021 CX-30  
2021 CX-5  
2021 CX-9

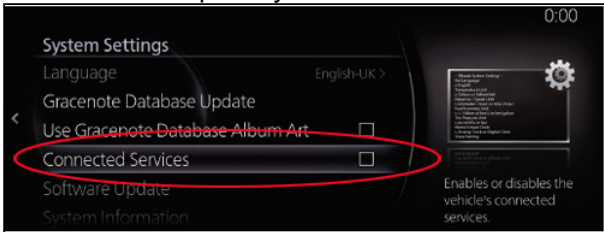
<ul style="list-style-type: none"> <li>• Connected Service contract has ended (Subscription expired)</li> <li>• Customer deactivated Connected Services (Opt-Out)                             <ul style="list-style-type: none"> <li>◦ eMDCS Warranty Vehicle Inquiry will show Campaign <a href="#">CSP04</a> Status Closed</li> </ul> </li> <li>• TCU has not been initialized, go to <a href="#">SA-004/21</a></li> </ul>

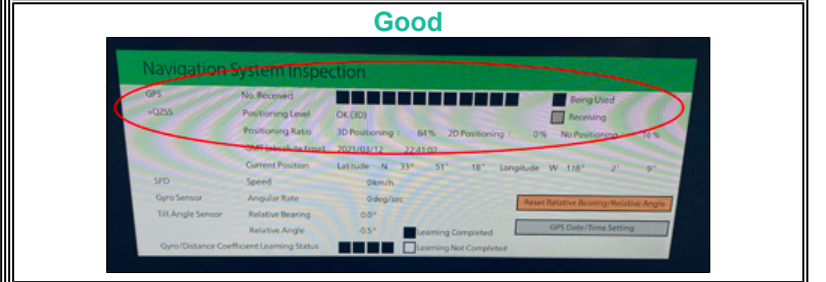
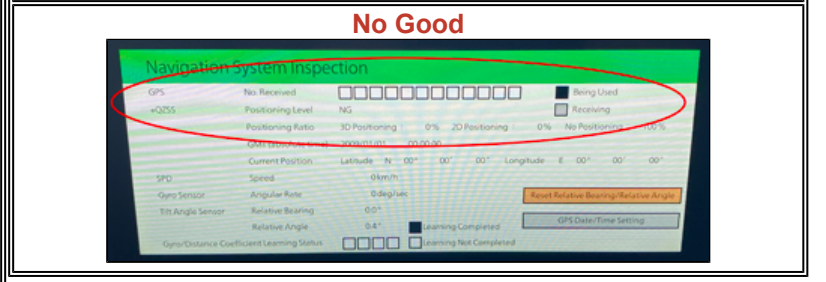
5. Compare Tel antenna No. 1 signal strength with good known vehicle near by.

- **Good:** Contact Hotline for technical support.
- **No Good:** Swap Tel antenna No. 1 with known good vehicle.

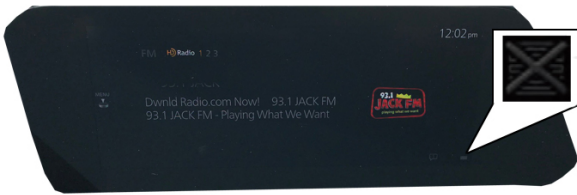
- The customer is not able to activate Connected Services via the MyMazda app after CSP06 completion.
- MAZDA CONNECT connected vehicle reception strength icon is missing or shows unsubscribed after CSP06 completion.

Go to [CSP07 Repair instructions](#).
