# Service Alert

Subject:	
APPLE CARPLAY™ / ANDROID AUTO™ FREQUENTLY ASKED QUESTIONS (FAQ)	Service Alert No.: SA-029/21
	Last Issued : 06/04/2021

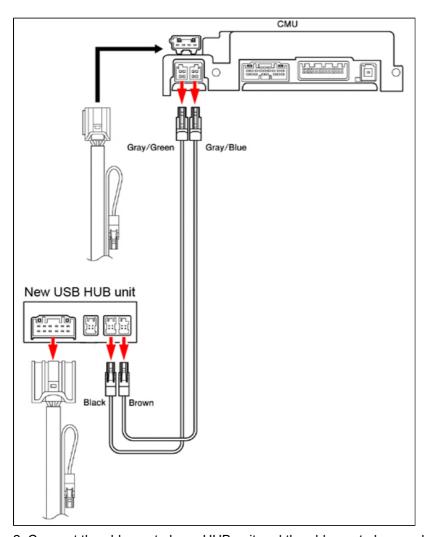
Cannot update CMU software after smart phone Cable Set Kit (P/N C922-V6-605) installation.

This may be caused by smart phone Cable Set Kit (P/N C922-V6-605) installation error. The hardware was installed before CMU software update by smart phone flash drive.

Failure: In some cases, the CMU will not recognize the new HUB unit, so CMU software update by smart phone flash drive is not possible.

1. Disconnect the new smart phone HUB unit and the new smart phone cables from the CMU.
