SERVICE BULLETIN

APPLICABILITY: 2019-2021 Forester with Seat Position Memory **NUMBER:** 07-197-21
SUBJECT: Seat Position Memory Switch- Loose Fit **DATE:** 06/29/21

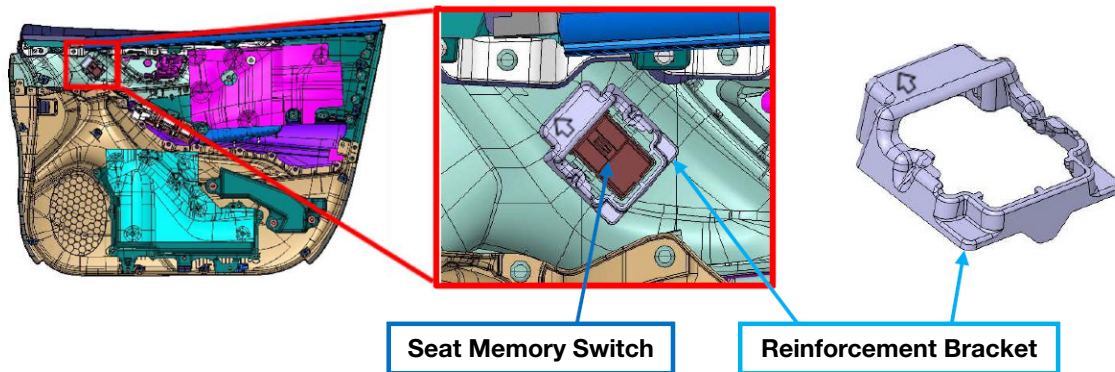
This bulletin announces availability of a NEW reinforcement bracket for the seat position memory switch. The bracket has been designed to fit on the existing switch without modification. The new bracket adds increased rigidity to optimize retention of the memory switch. Install this new bracket should a customer experience a loose-fitting seat memory switch in high ambient temperature conditions.

Part Description	Part Number
BRACKET-REINFORCEMENT, SWITCH	94286SJ100
