# McLaren Elva – Install Additional Air Duct Sealing – Active Air Management System (AAMS)

**Bulletin type:** Service Campaign  
**Reference number:** SCB 26 A 001  
**Attention:** Retailer Service Managers and Retailer Technicians  
**Affected vehicles:** McLaren Elva  
**Situation:** Potential for excessive wind noise generation from the AAMS duct during higher speed driving  
**Procedure:** Action affected vehicles during next Retailer visit. Please refer to the information outlined in this document to install additional moulded sealing strips across the AAMS duct  
**Date:** 24<sup>th</sup> June 2021

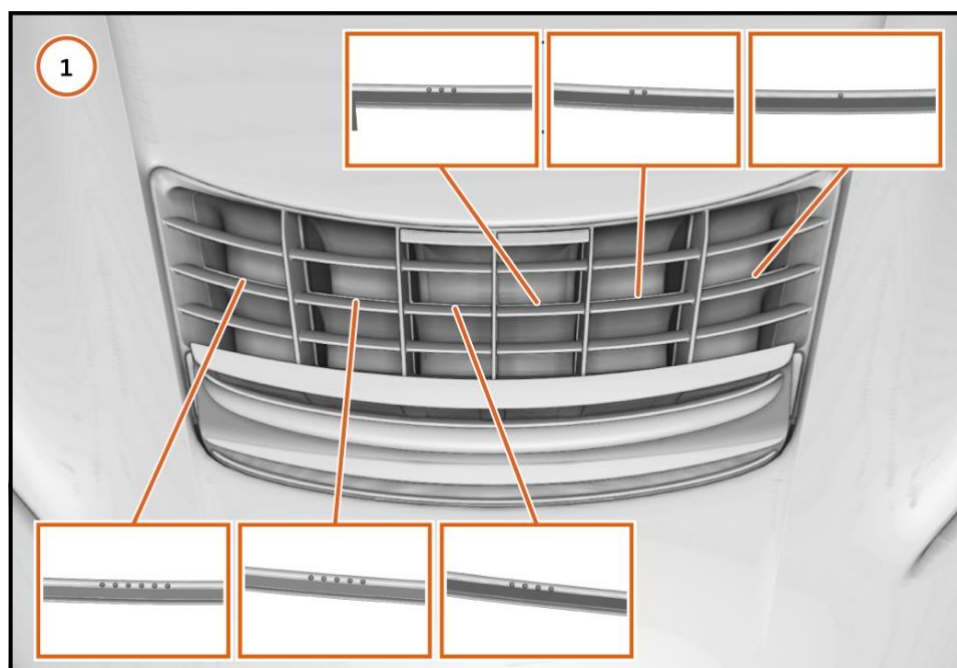
Through continuous product quality monitoring, it has been identified that a known number of McLaren Elva vehicles, have insufficient sealing in the AAMS duct. This could cause a customer complaint of excessive wind noise at higher driving speeds; therefore, a preventive rework solution has been released.

Extract from WI document - Installation position of additional sealing strips

Part Number	Part Description	Quantity Required
26AD315SP	AAMS Duct Finisher Seal (kit containing 6 seals)	1
