Technical product information

Topic	New Continental GT and GTC - Rattle / Buzzing Noise - Head-Up display
Market area	Bentley: worldwide (2WBE),Hongkong-Macau (5HK)
Brand	Bentley
Transaction No.	2052431/6
Level	EH
Status	Approval
Release date

Rattle / buzzing noise from Control Unit for Head-Up display - dashboard upper trim panel.

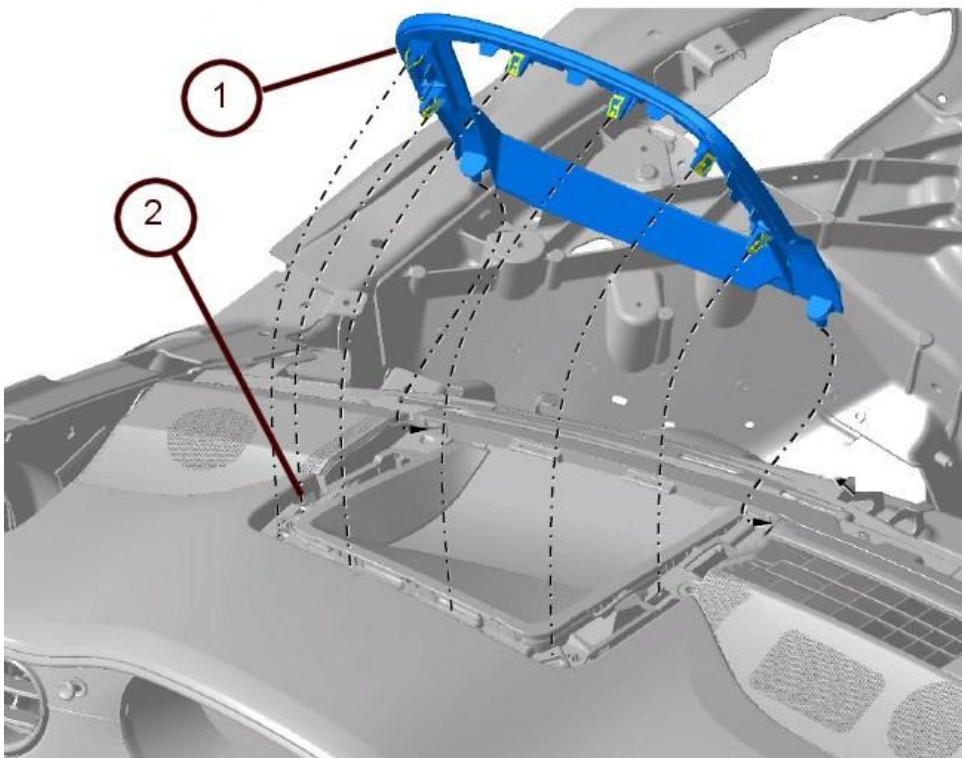
- Relative movement between Control Unit for Head-Up Display and associated Trim Ring – Figure 1
- Contact between the dashboard and dashboard upper trim panel.
- Head-up Display internal fault

1 – Trim Ring

2 – Control Unit for Head-Up Display

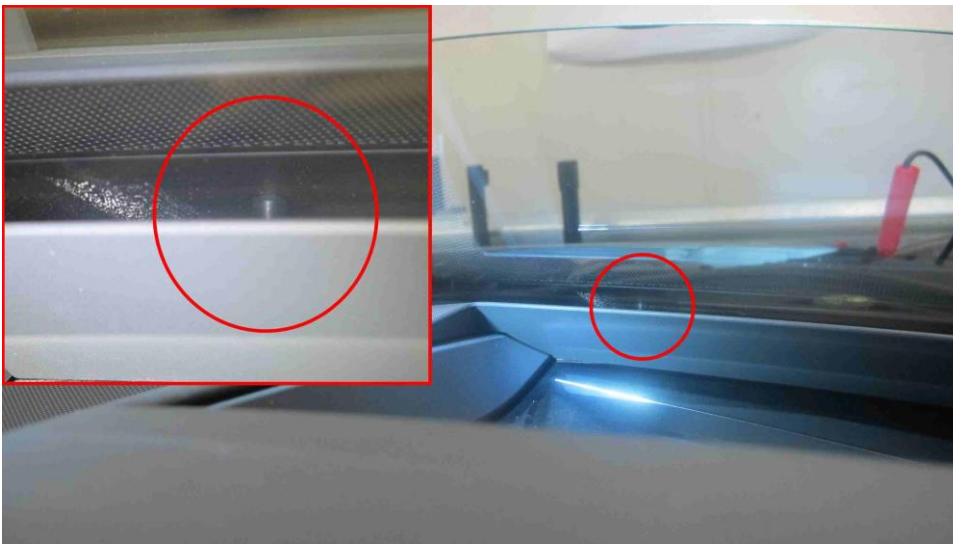
Figure 2

Bump stop introduced to the dashboard at the forward area of the HUD – Figure 2.
