Technical product information

Topic	Rotating screen alignment
Market area	Bentley: worldwide (2WBE),Hongkong-Macau (5HK)
Brand	Bentley
Transaction No.	2051526/6
Level	EH
Status	Approval
Release date

New Continental GT - New Continental GTC and New Flying Spur

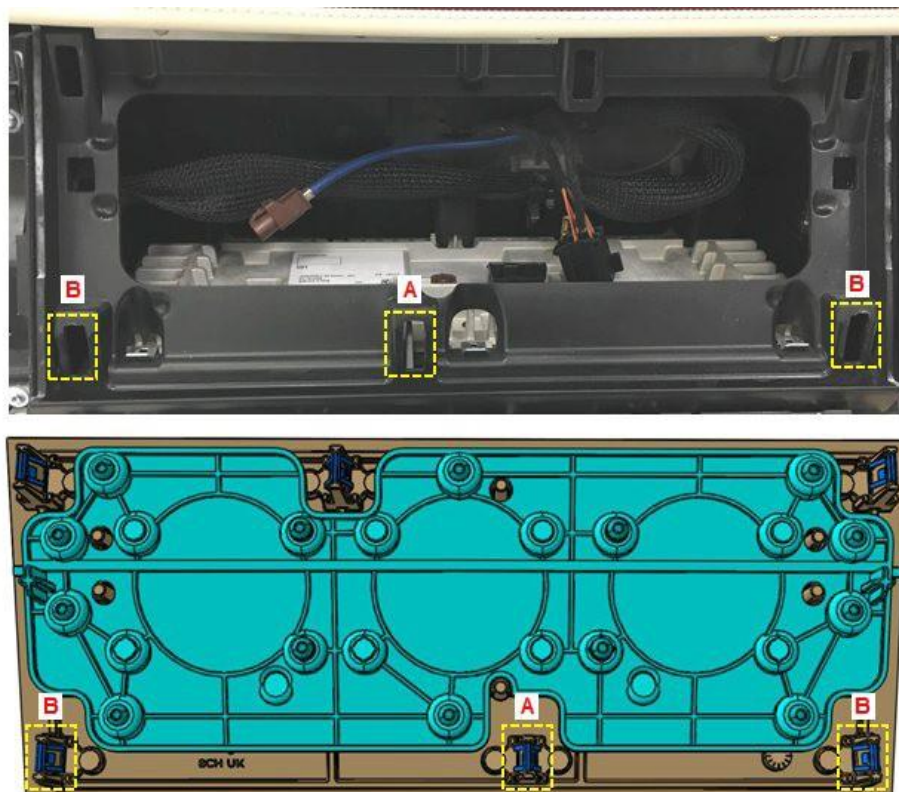
Figure 1

The veneer face fascia panel is fixed to the “BRD” by six locator pins and receiving holes. See Figure 1.

The following locator pins (A & B) control the position of the fascia panel as follows:

A = Side to side axis

B = Up and down axis

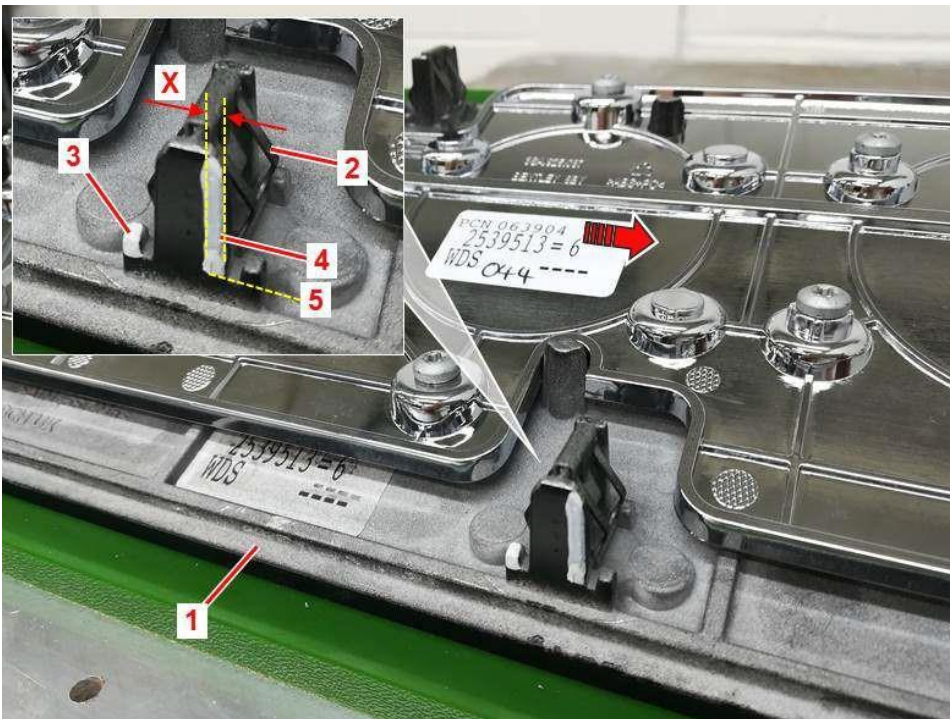
Figure 3

i Only the centre lowermost locator pin shown governs the side to side movement of the fascia panel. Only this locator pin will require modifying.

Place the veneer face fascia panel (1) face down on a soft, clean and protective work surface and mark accordingly the direction in which the panel needs to move (arrow). See Figure 3.

Remove the spring retaining clip (2) from the lowermost locator pin. If the fascia panel requires moving by 0.5mm then remove the same amount of material (X) from the appropriate side of the lower centre locator pin (4) as shown on the aluminium substrate casting. In addition, file the trailing RPS point (3) flat, level with the recess. See Figure 3.

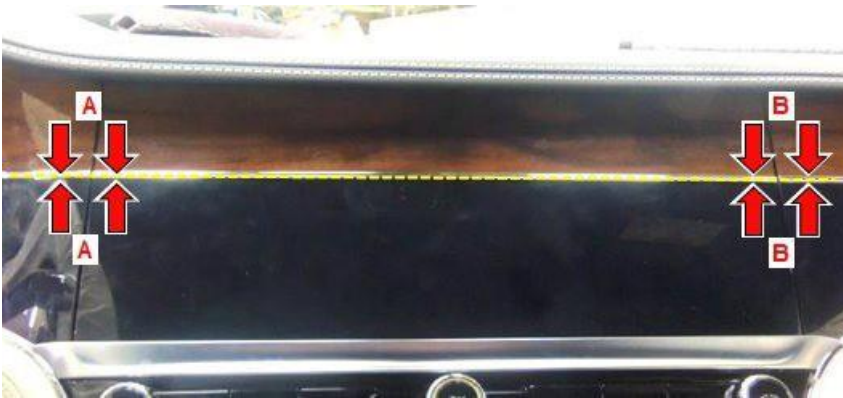
Figure 7

Visually check that the chrome brightware strip on the "veneer face" fascia panel is aligned with the chrome strips at points A & B on the passenger and drivers side fascia panels. See Figure 7.

The specified tolerance in the vertical plane (A & B) is 0.5mm.

If the chrome brightware strip on the "veneer face" fascia panel is out of line, carry out the following to adjust the panel.

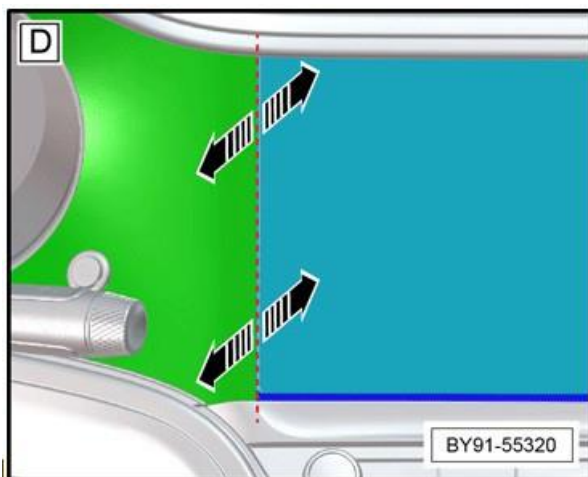
Measure the profile (D) between the “BRD” veneer face fascia panel and the passenger and drivers side fascia panels. See Figure 12

The specified setting dimension for the “BRD” fascia panel is -0.5mm (under flush) +/- 0.5mm tolerance and MUST be equal on both sides.

If either of the passenger and drivers side fascia panels are out of tolerance and require adjustment, make a note of which point requires adjustment and by how much on each panel.

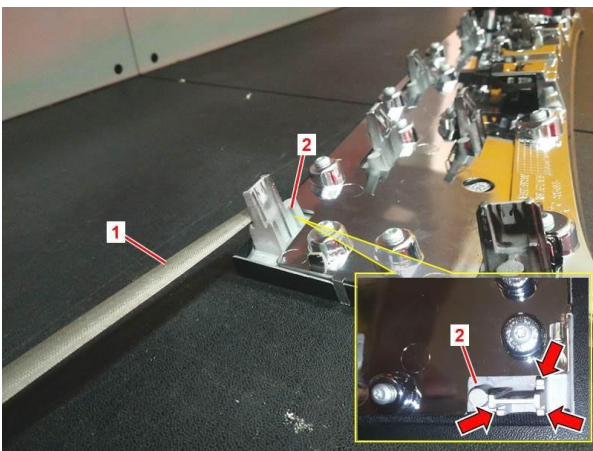
Figure 14

i Note. The upper locator pin (2) has three “RPS” points (arrows) whereas the lower locator pin only has two “RPS” points.

Carefully file the “RPS” points (arrows) by the required amount that the fascia panel needs to move in.
