Countries: CANADA, UNITED STATES Document ID: IK0700113  
Availability: ISIS, FleetSIS, NotSIR Revision: 1  
Major System: EXHAUST Created: 5/20/2021  
Current Language: English Last Modified: 6/3/2021  
Other Languages: NONE Author: Mujtaba Aidroos  
Viewed: 148

Title: HX Rattle and Squeak Service Instructions

Applies To: HX models exhibiting complaints of a rattle or squeak from the vertical exhaust slider due to wear or too much pre load

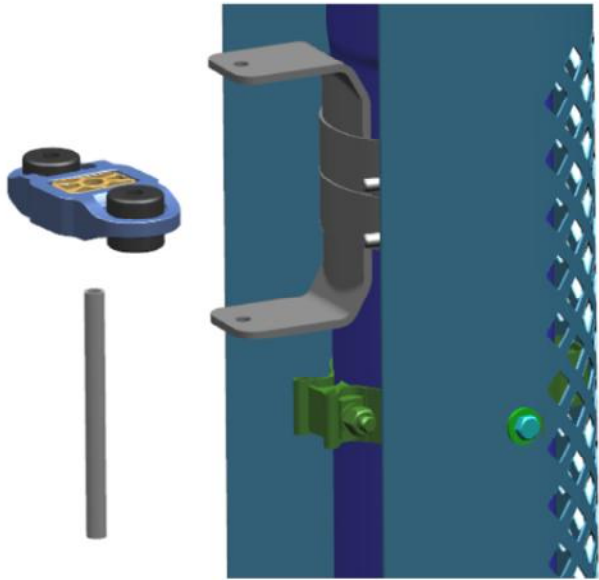
Slide Rod out of the slider

Rotate pivot 90 deg and slide out of mount

Replace with a new pivot PN 4146378C2

[4146378C4](#) (Will be available for service in late 2

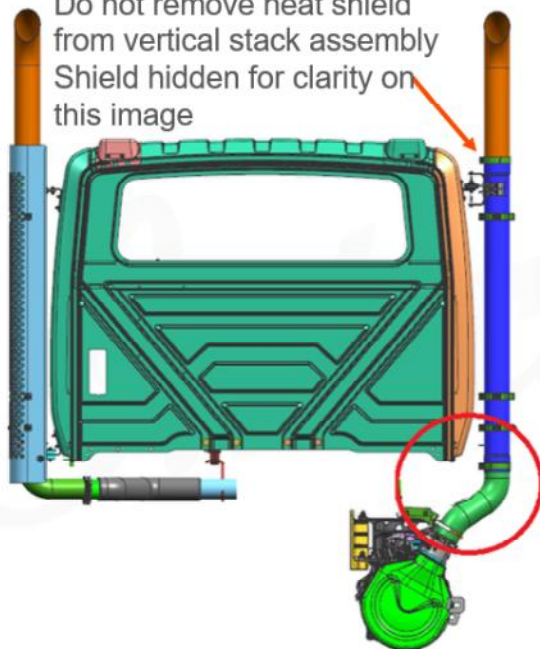
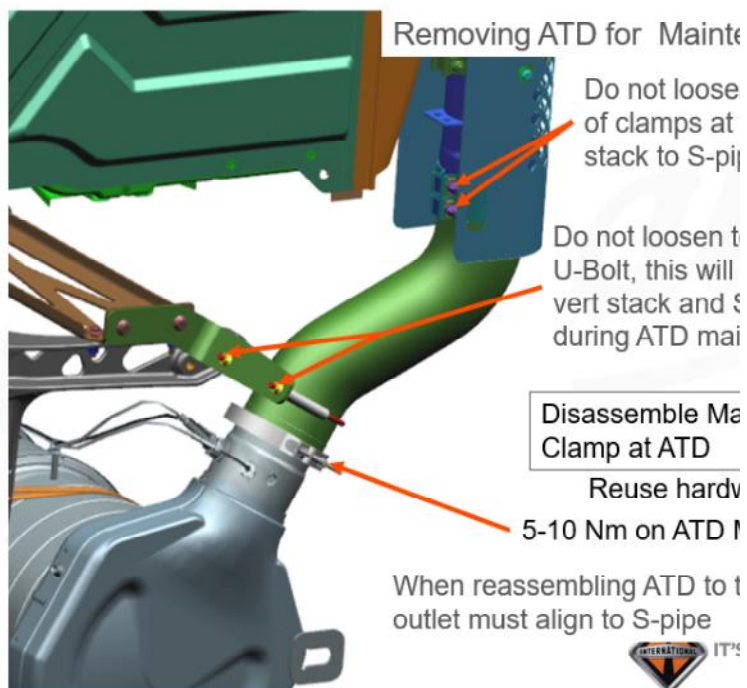
Do not remove heat shield from vertical stack assembly  
Shield hidden for clarity on this image
