IK0900141

**Title:** MV Air Compressor Inlet Hose Rubbing

**Applies To:** MV's with Cummins B6.7 built 11/20/2019 - 11/06/2020

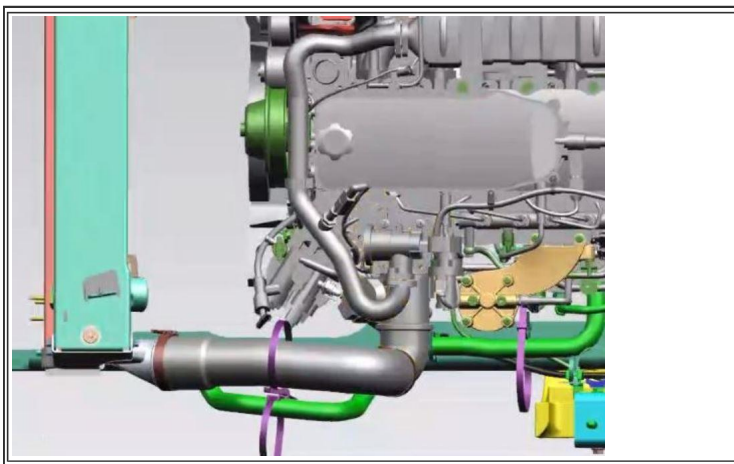
**Figure 1: Top View- CAC pipe saddle & tie strap centered**

Navistar has identified that in some rare circumstances the Air Compressor Inlet Hose from the Charge Air Cooler, may chafe due to insufficient route and clip. The description and images below offer instruction on sufficient route and clip.

Air Compressor Intake Hose clipping point on the CAC pipe shall be centered horizontally and securely fastened with a saddle & tie strap
