**Countries:** CANADA, UNITED STATES **Document ID:** IK1201440  
**Availability:** ISIS, Fleet!ISIS, IsSIR **Revision:** 2  
**Major System:** ENGINES **Created:** 8/25/2019  
**Current Language:** English **Last Modified:** 6/1/2021  
**Other Languages:** NONE **Author:** Greg Scheff  
**Viewed:** 597

**Title: A26 Fuel Delivery Pressure Sensor (FDP) and Harness Pigtail Eliminated**

**Applies To: All A26 Engines**

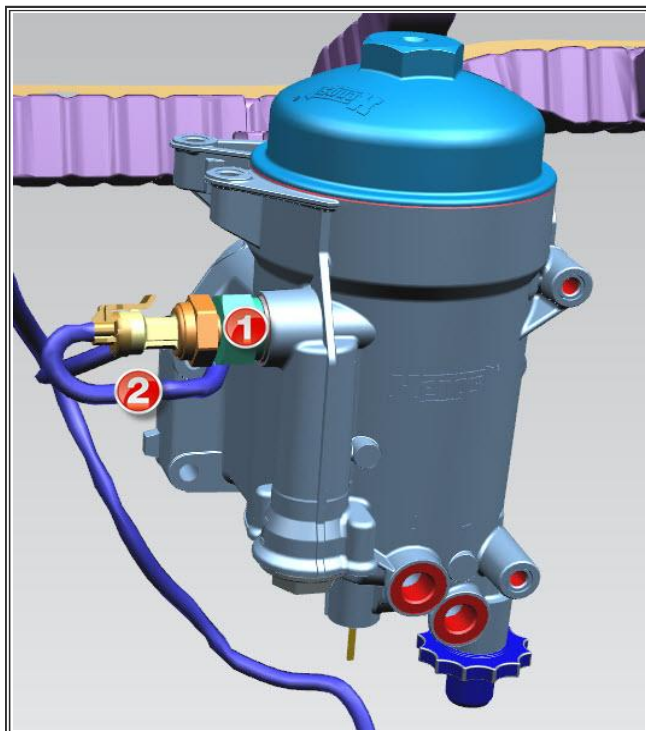
**Figure #1: Engine Mounted Fuel Filter Housing**

This document will explain the removal of the fuel delivery pressure sensor and harness pigtail on the A26 engine. The early built A26 engines had the fuel delivery pressure sensor installed in the engine mounted fuel filter housing (Figure #1) however, the ECM never monitored the signal from it. Later the sensor was removed, the port was plugged, and the engine harness was modified to remove the pigtail and the connector for it.

Item 1: Fuel Delivery Pressure Sensor (FDP)

Item 2: FDP harness pigtail and sensor connector

**IT IS ACCEPTABLE** to install a C92 harness on a newer engine not equipped with the FDP sensor.

- The unused pigtail (Figure #1 item 2) and connector for the FDP sensor can simply be tied off and tucked out of the way OR
- The pigtail (Figure #1 item 2) can be cut off, and apply heat shrink tubing at the wire ends
- The wiring for those circuits to the ECM are not used
