## DTC U012100 - Lost Communication With Anti-Lock Brake System (ABS) Control Module

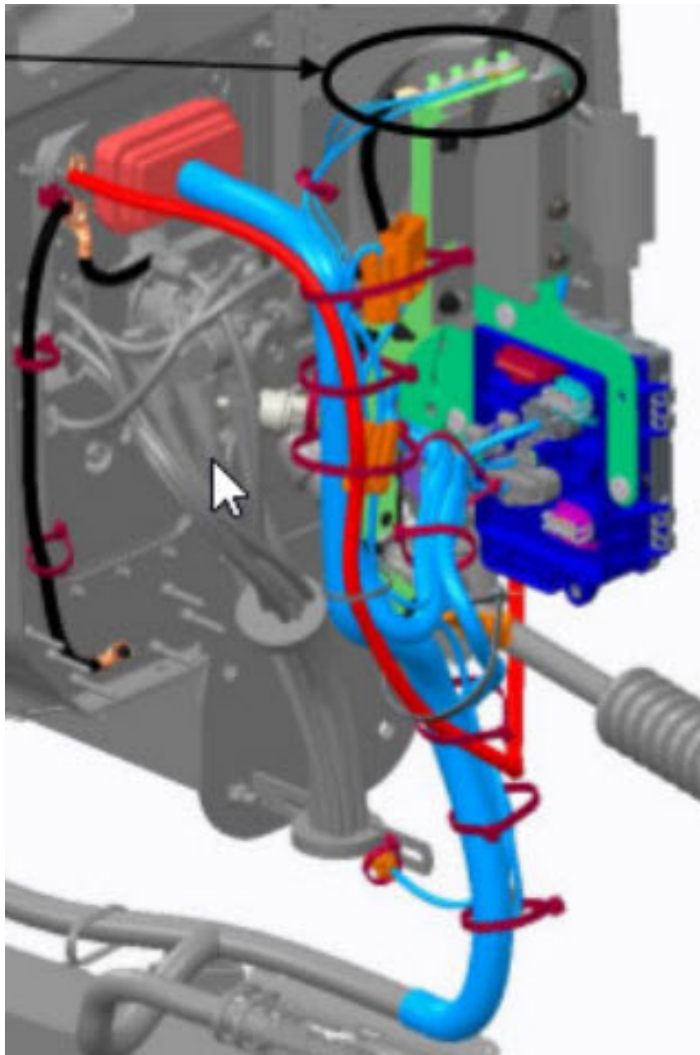
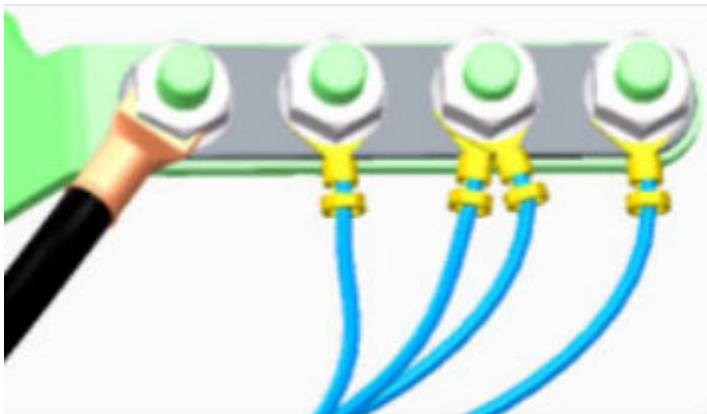
Fault Code U012100 may be caused by poor connection at the X209 Ground Junction. If DTC is present do the following:

The X209 ground junction is located on the drivesside bulkhead. See images below.

1. Disconnect the battery.
2. Remove all connections at the X209 Ground Junction.
3. Thoroughly clean all surfaces.
4. Reassemble connections.
5. Apply protective coating.
