Mack Chassis - Models GU / GR - Constant Correction To Center

GU/GR, CHU, CXU, AN Constant Correction To Center

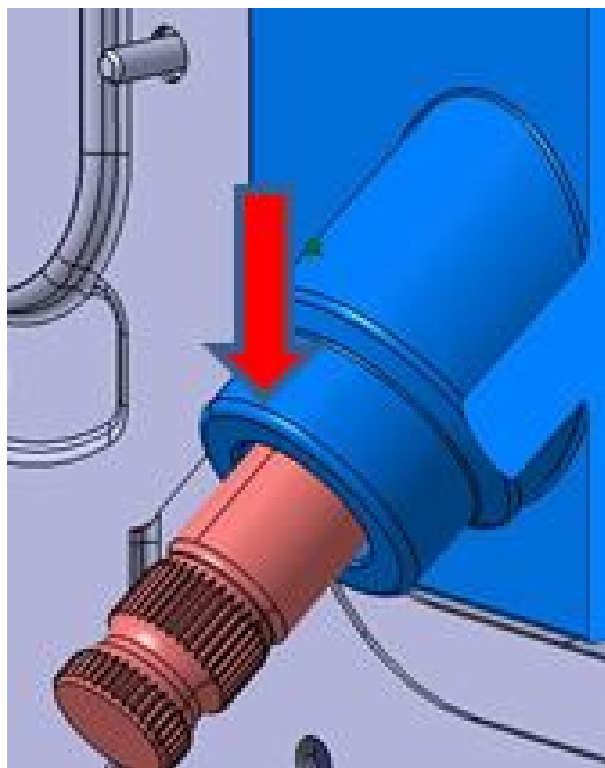
GU Alternate Cab Wall Boot

- For GU vehicles produced **prior** to 1st week of January 2017. A change of the upper steering column happened in November of 2014 (4mm shorter). With this change we believe an interference may be present with the column boot on the cab wall. This may create undue pressure on the column shaft as it comes out of the cab wall.

- Pressure from the boot may be applied to the steering column shaft restricting it from turning freely. To check, disconnect upper steering shaft at base of column shaft. Remove boot (there may be a noticeable movement upward of the shaft). Reassemble steering shaft to steering column and test drive. If problem is resolved replace boot with 84723313 (Introduced into production 2017w01). Test drive after boot replacement to ensure problem is resolved before returning truck to customer.

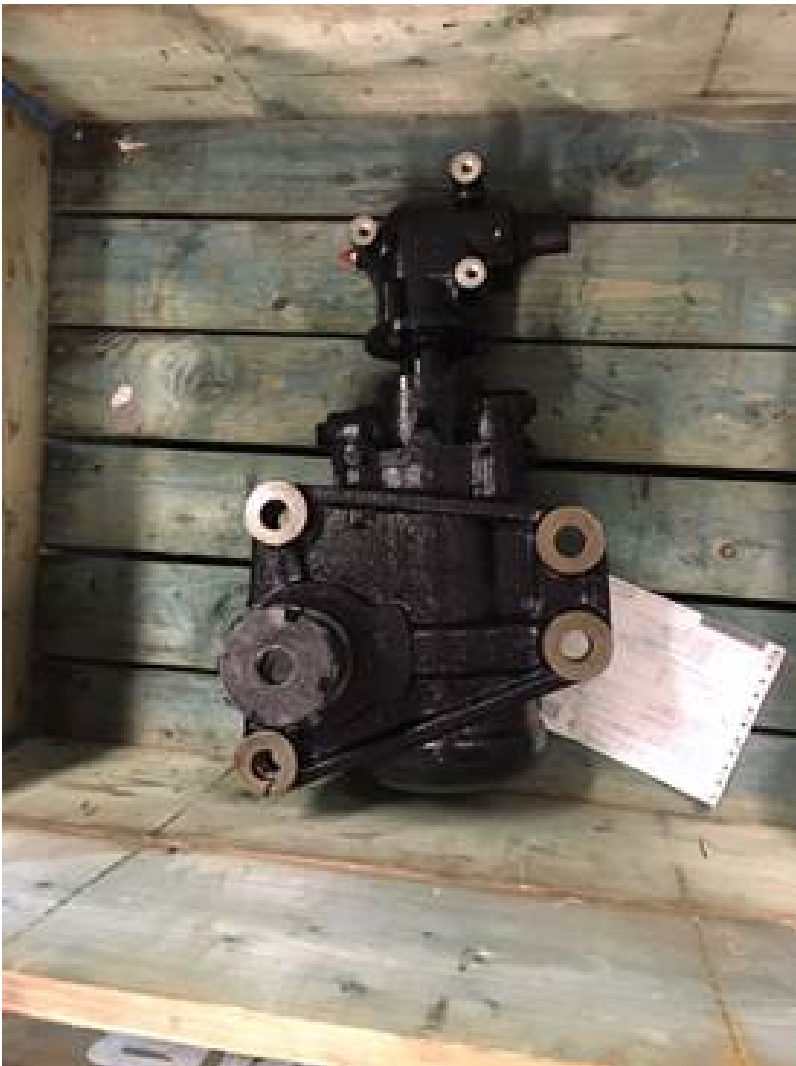
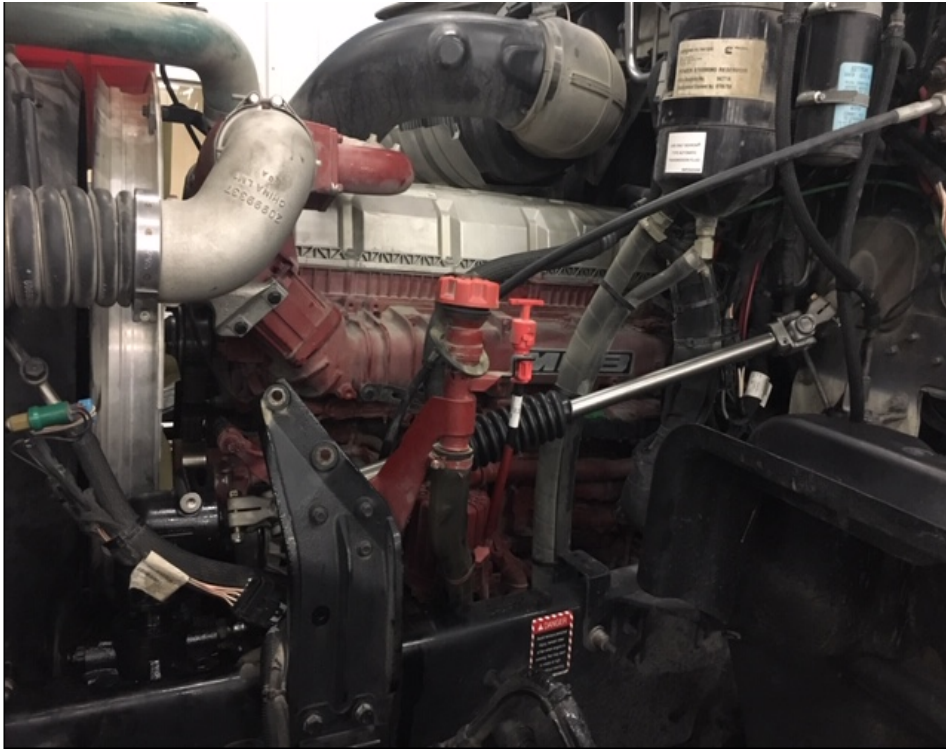
GU / GR Without Assist Gear - Alternate Steering Gear/Shaft Configuration

Live UI On non-assist gear trucks we have a steering gear from Sheppard with a 90° miter box on top. This can be used with an Anthem 1

piece steering shaft.

- Sheppard steering gear part # 8148-SD110PAE3.
 - Steering shaft 84703023 x 1.
 - Screw 25106380 x 2.
 - Nut 25098472 x 2.
-
- Follow Impact service procedures for gear and shaft replacement.
 - Clearance to any component must be a minimum of 1".
 - Pillow block bearing bracket may be left in place and trimmed off or not.
 - Slightly stiffer steering may result. May improve as components wear in.
 - Use [84734967](#) as the causal part in the claim.
