PRODUCT CAMPAIGN BULLETIN

APPLICABILITY: 2017MY Impreza

NUMBER: WTN-74R

SUBJECT: Reprogramming File Availability to Optimize Rear View Camera Operation on Harman Gen 3 Audio and Navigation Head Units

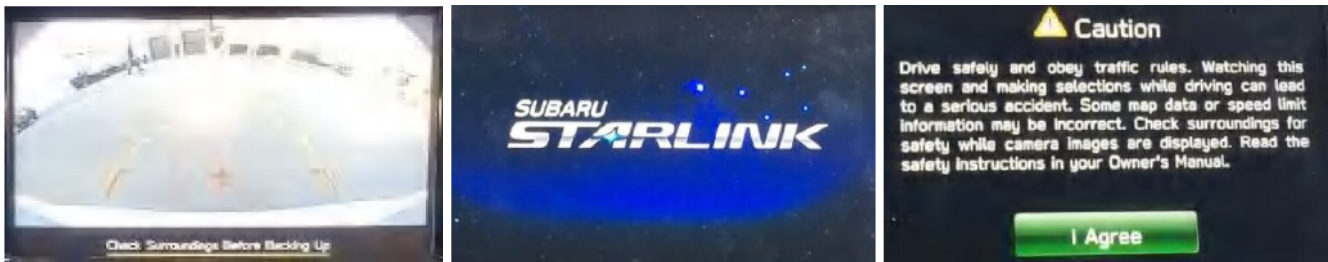
The main purpose of this campaign is to address display screen freeze-up during rear view camera display (when the shifter is in “R”). In addition, the screen may also freeze when either the Subaru STARLINK or Disclaimer Caution / I Agree is displayed.

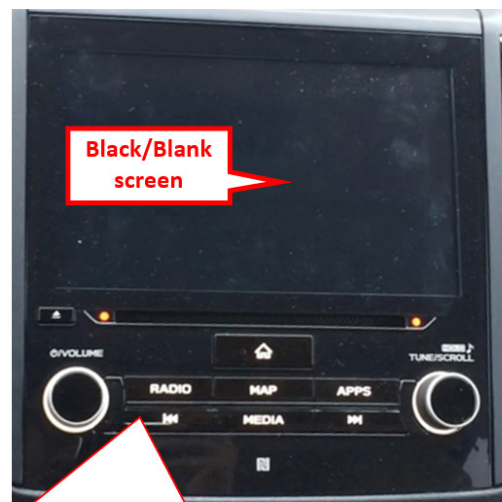
- 1) After switching the vehicle (ACC or IGN) on, the display screen goes black with no audio output and the hard key buttons are illuminated (on solid, or flashing / blinking).

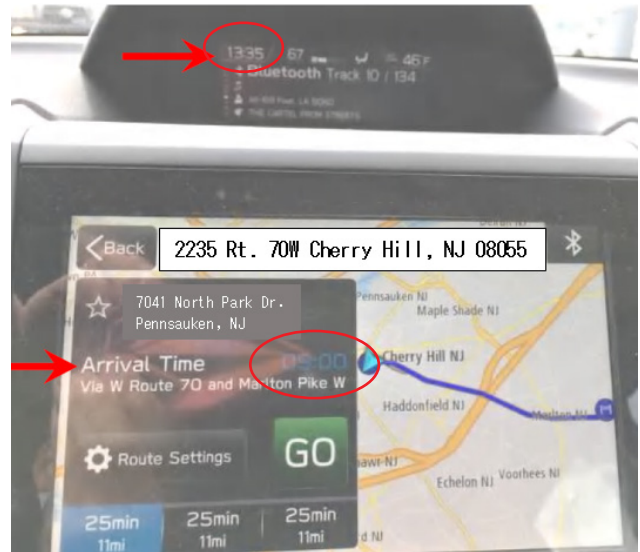
- 2) Time of day displayed in the MFD (Multi-Function Display) is incorrect and the arrival time displayed in Navigation units is also incorrect.

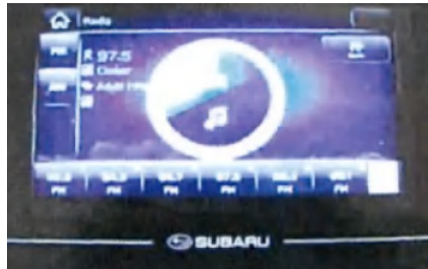
- 3) The time in the MFD automatically reverts back to a “default” setting, even after setting the time using “Manual” mode.
- 4) Audio volume goes to maximum automatically after one click of the volume up button on the steering wheel. In some cases, this condition may also occur without input from the operator. Maximum volume is also displayed on the screen.
