Articles Contained in this Issue

10 Recovery of Contaminated R-1234yf

12 Water Leaking Into Cabin From Door Trim- All Models and Model Years

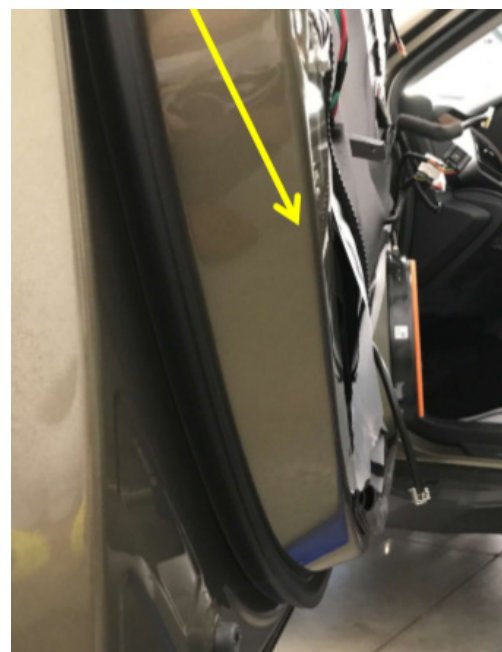
When a customer is concerned with water dripping from the door panel to side-sill or into the vehicle, do not overlook the sealing cover installation. Gaps in the cover's sealant can create a route for water to escape. This condition has been identified on all four doors and in some cases multiple doors on the same vehicle. When encountering this condition, first verify the door drain is free and clear by water testing. Water test with the window glass fully closed and the door open. Pour water down the glass from the outside of the vehicle. There is a small drain hole at the bottom of the door that water should drain from. If it does not, clear the drain and test again to confirm if debris blocking the drain was the only concern or not. After water testing the door and verifying the drain operates as designed, CAREFULLY remove the door trim panel and visually inspect the sealing cover. If inspection finds any gaps in the sealant, do not replace the sealing cover. Instead repair the condition by carefully removing and reinstalling the sealing cover (making sure to apply even pressure around the parameter of the cover) then visually verify there are no remaining sealant gaps. A final water test will confirm the is repair.
