Articles Contained in this Issue

01 Understanding DTCs and How to Proceed Properly with Repairs

07 WRE-21 Ignition Coil Connector Removal and Wire Clip Loss- How to Repair

12 Ascent Sunroof Frame Assembly

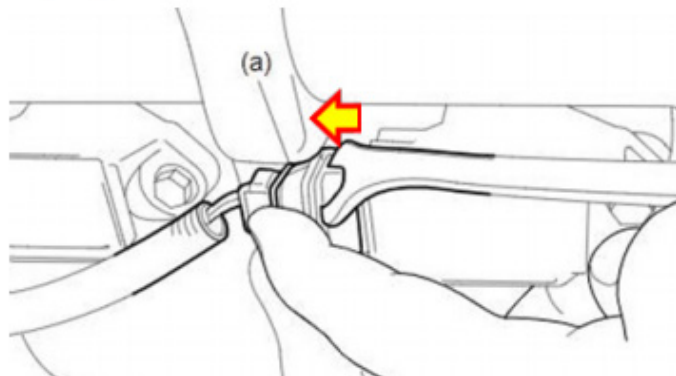
Techline has received reports of some retailers calling and looking for the metal retaining clip from the ignition coil connector on the engine harness. Technicians are prying the metal retaining clip off to remove the connector from the ignition coil. This is the incorrect and improper way to disconnect the connector. The metal retaining clip should not be removed in order to disconnect the connector from the ignition coil. The metal retaining clip should be pushed down, and the connector pulled off from the ignition coil. This information is in the Service Manual and was added as an update in the WRE-21 bulletin. It is provided here as reference.

TIP: When disconnecting the harness connectors from the ignition coils, squeeze the wire retaining clip (a) and push the connector off using a trim clip tool as shown in the illustration below. **DO NOT** remove the wire retaining clip from the harness connector.

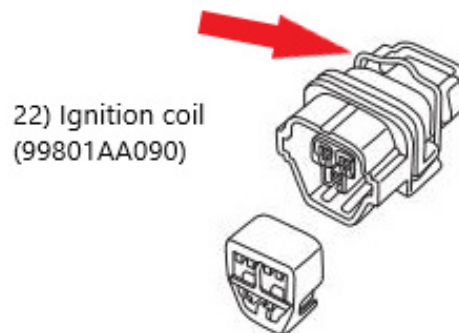
The metal retaining clip itself is not available separately. If the clip is lost the connector will need to be ordered. The new connector comes with the metal retaining clip installed as shown here.

Supply of these connectors is extremely limited and must be special ordered. Retailers need to order these connectors **only as needed** using the existing VOR parts order process. They must then contact the PICs team, after placing the VOR order, to have the connector(s) released.

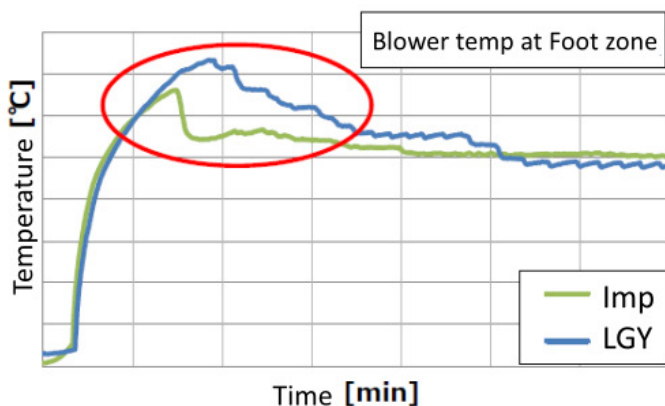
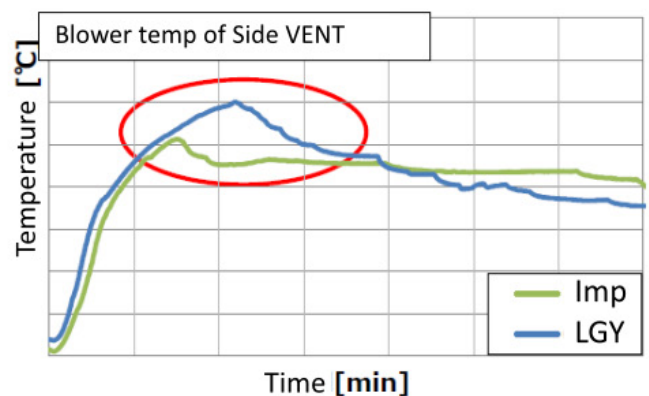
The customization in the SSM4 for the target value can be adjusted from (+)3 to (-)3. This is not a direct relation to degrees, but levels. It is important to note, changing the target value will also change the blower motor ramp settings. The customer may notice the fan does not operate with the same characteristics as it did before the adjustment. This is a normal operating condition.

The A/C CM controls the blower temperature/speed in order to reach the target temp. This will also be affected depending on the gap between the target temp, actual temp and outside temp. The fan may initially blow higher and stronger to acquire the target temp selected. Depending on parameters, this may also create an overshoot scenario in which the customer may feel the system is too hot/cold. This is also a characteristic of how the system operates.

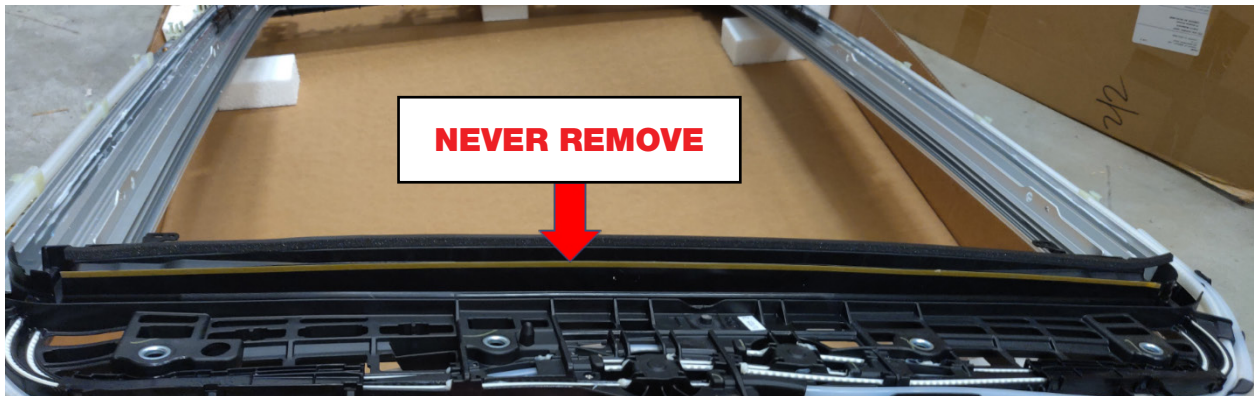
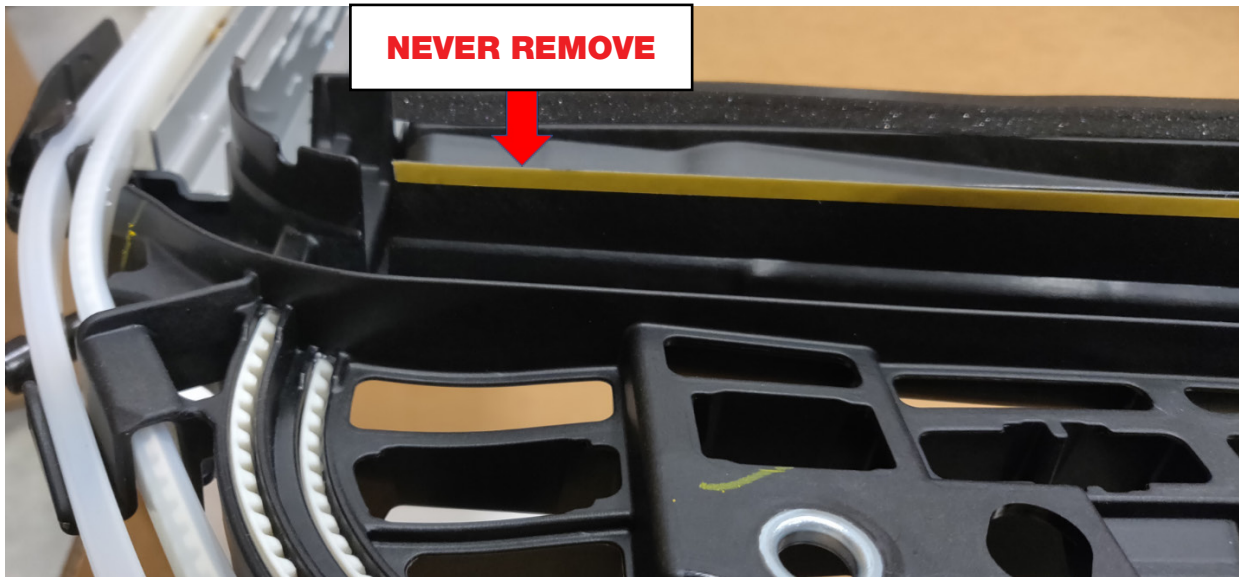
When diagnosing for air/water leaks, dislodged/deformed molding, performing adjustments, or when replacing the sunroof frame assembly, **DO NOT** remove the yellow tape from the double-sided tape installed on the sunroof frame assembly. It is required to remain in place by design.

NOTE: The yellow tape is not available separately/serviceable, if removed, the sunroof frame assembly will need to be replaced.
