SERVICE BULLETIN

APPLICABILITY: All 2015-17MY Vehicles with Fujitsu TEN (F10) 7in. Multimedia Navigation (AVN) & Display Audio Units
SUBJECT: “Gen 2” & “Gen 2.1” Operating Tips
NUMBER: 15-177-14R
DATE: 10/16/14
REVISED: 06/25/21

INTRODUCTION:

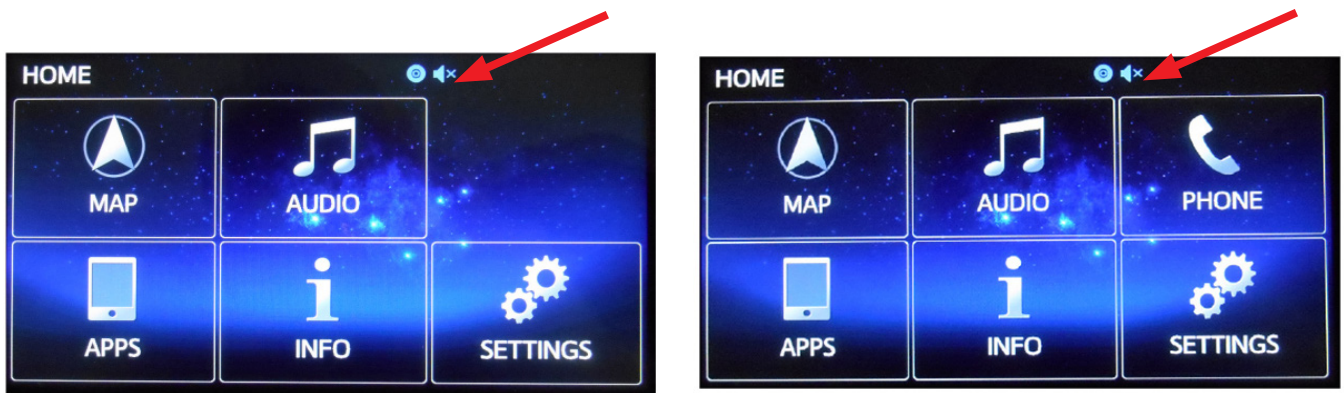
CONDITION: #5: A “Phone” button is not displayed on the HOME screen.

POSSIBLE CAUSE:

- Microphone is not properly connected to the head unit
- Microphone detection wiring (MIC DET) is open
- Microphone unit is defective

RECOMMENDATIONS:

- Confirm the microphone wiring is securely connected to the head unit.
- Confirm there is not an open circuit or short in the Microphone detection (MIC DET) wiring.
- After the wiring has been confirmed to be OK, replace the microphone if necessary.

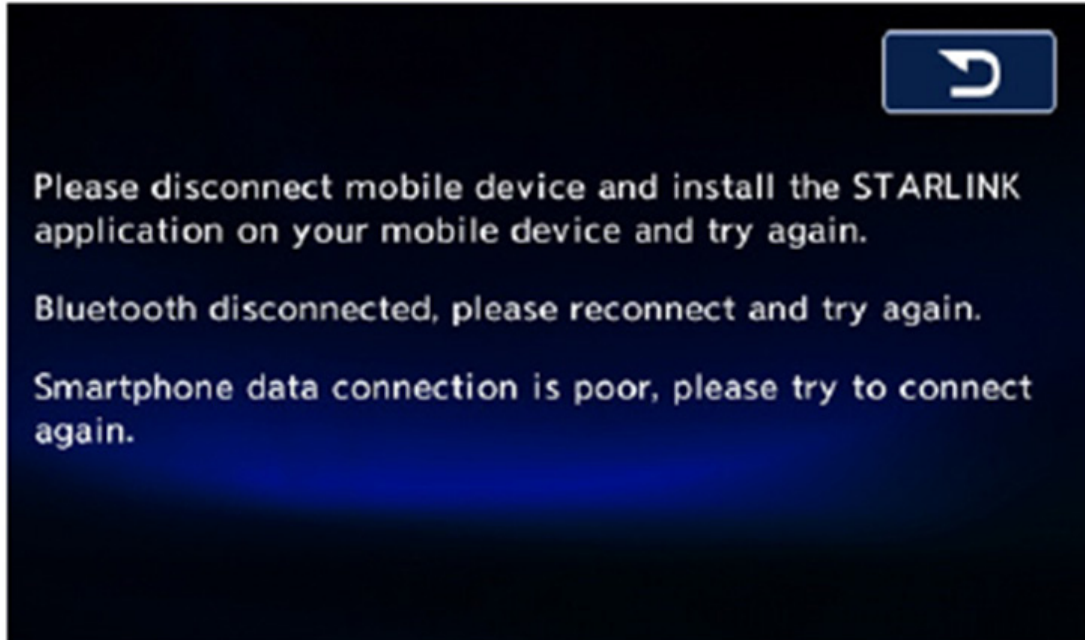
CONDITION #8: When selecting the STARLINK function on the head unit, an error message appears on the screen as shown below.

CAUSE:

- STARLINK application on the Smartphone was not loaded and/or launched on the Smartphone prior to selecting the STARLINK function on the head unit. Therefore, Smartphone cannot communicate with STARLINK Server.
- Smartphone has not been paired with the head unit for Bluetooth connection

RECOMMENDATIONS:

- Check if Bluetooth connection indicator appears as shown below on the screen of the head unit. If not, the Smartphone needs to be paired to the head unit via Bluetooth connection.

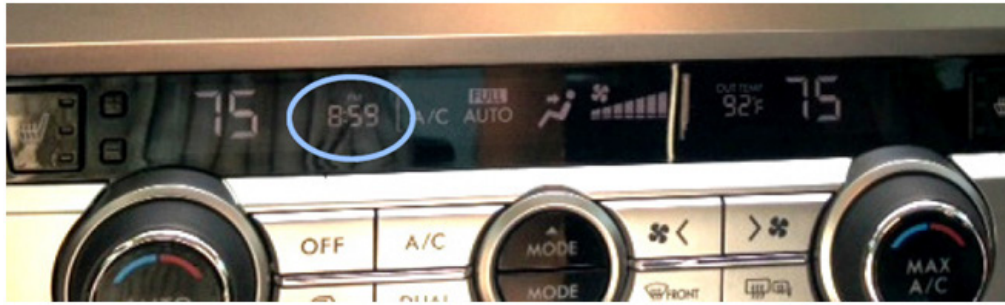
CONDITION #23: The clock display on HVAC panel is incorrect even when “Auto Adjust by GPS” is selected on the Clock settings menu.

The correct time is 4:59 pm but HVAC display shows 8:59 pm.

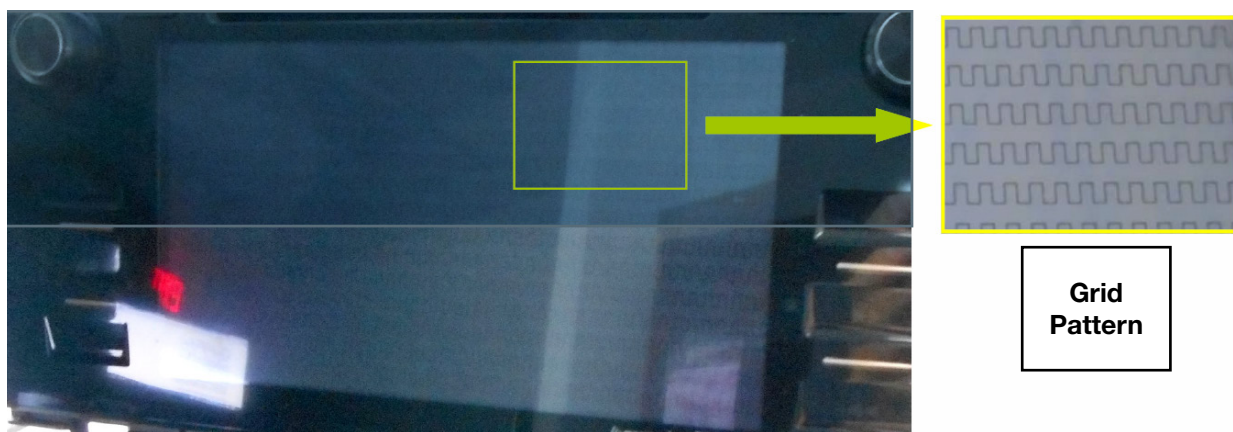
CONDITION #37: Grid pattern visible on the entire display area, all the time.

CAUSE:

Defective Display unit.

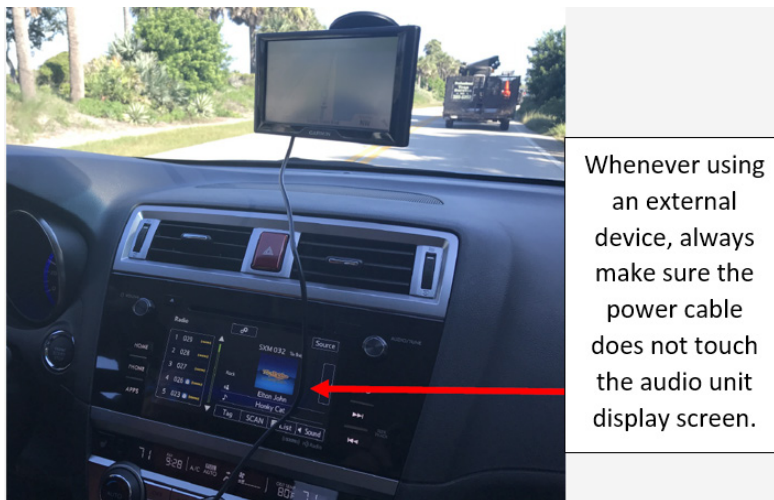
CONDITION #39: Unit freezes or locks up with no response to touch screen inputs.

CAUSE:

A power cord from an auxiliary device (e.g. GPS or cell phone cord) placed on the dash or attached to the windshield may be coming in contact with the display screen and inadvertently be causing a touch button to be continually “pressed”. When this condition occurs, the result is that none of the other buttons will respond to any user touch inputs.

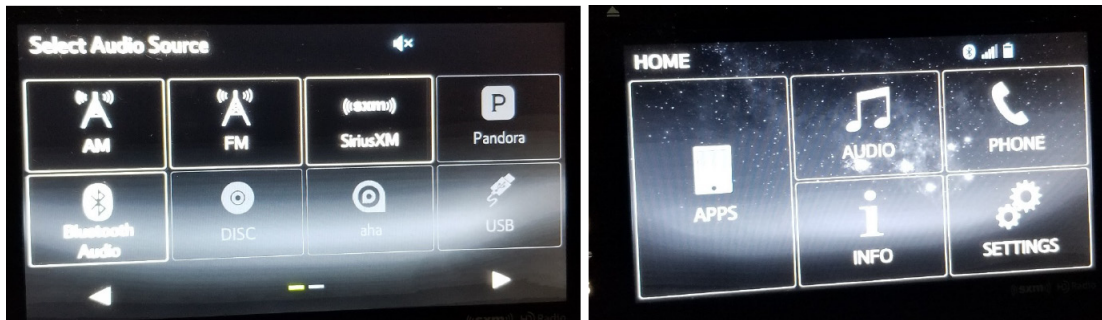
CONDITION #40: Display background color uneven, a “smile” -type image appears.
(Applicable to 2015-16MY Impreza, 2015-17MY Crosstrek, 2016-18MY Forester and 2015-17MY Legacy / Outback)

CAUSE:

This condition is NOT a defect. It is actually a background image of Subaru STARLINK which becomes visible when the contrast is set to the highest setting as shown in the screen shot below.

RECOMMENDATION:

Readjust the contrast to a lower setting.

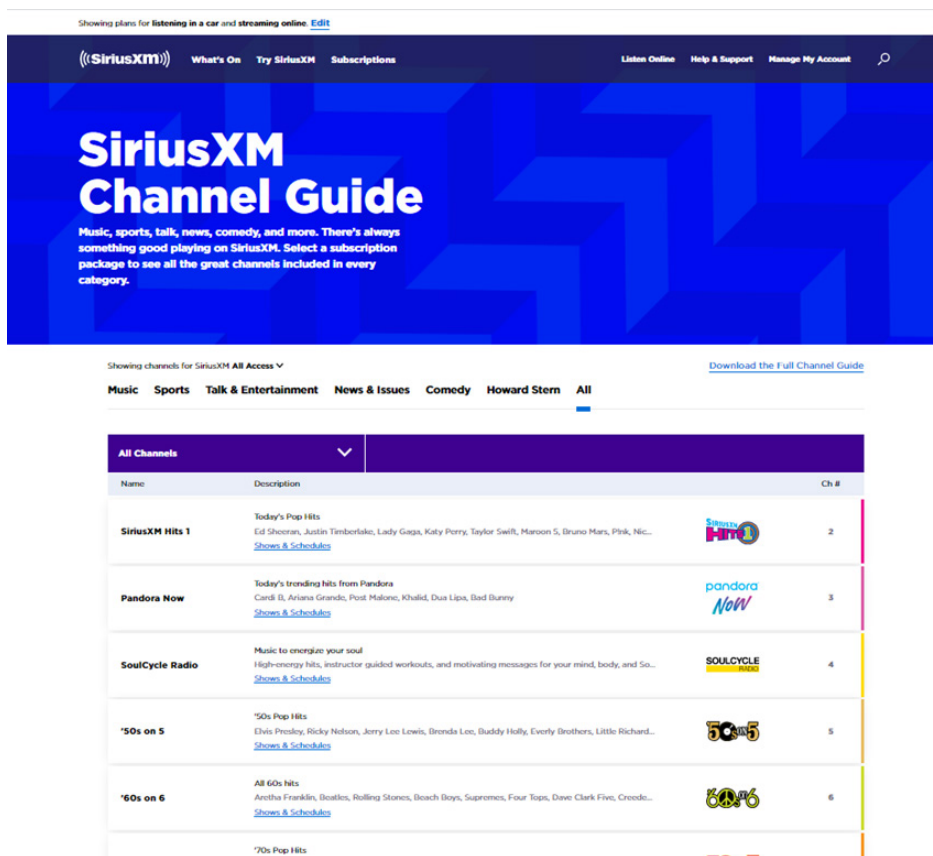
CONDITION #41: SXM operation freeze: not able to select SXM source or preset SXM channel.
(Applicable to 2015-16MY Impreza, 2016-2018 WRX/STI, 2015-17MY Crosstrek, 2016-18MY Forester and 2015-17MY Legacy / Outback)

CAUSE:

Over time, SXM channel lineup is revised resulting in some channels to no longer be active. If an inactive channel is stored in the head unit Mixed Preset, it could result in the SXM source being unavailable. It is a good practice to obtain the list of all active SXM channels from the SXM website, whenever addressing a SXM operation concern (<https://www.siriusxm.com/channels>).
