Y1A Taycan - Thermally and noise insulated rear window glass cracked

Revision	Release Date	Changes
0	June 4, 2021	Original document

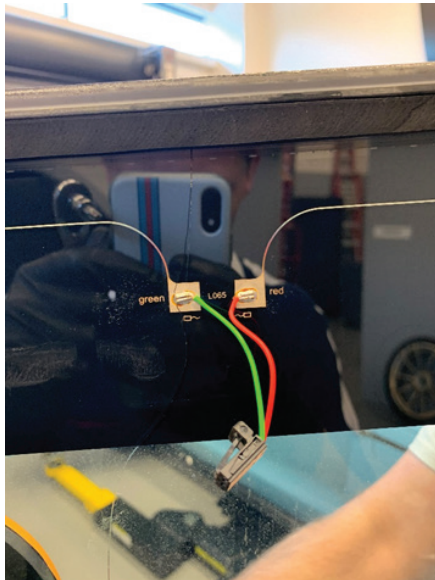
1. Soldering points at the top of the inside of the glass

The crack is a stress crack that begins at one of the two soldering points at the top of the inside of the glass, and propagates towards the lower part of the rear window.

Figure 1: Crack at the soldering points

Note: The crack can be found at either soldering point (red or green).

To resolve this issue, please replace the rear window glass as instructed in *Workshop Manual WM 648619 – Removing and installing rear window.*

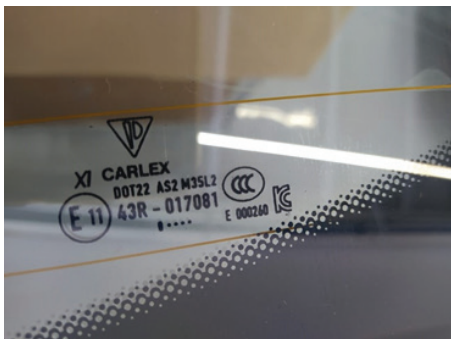
2. Manufacturing stamp at the lower right corner of the outside of the glass

Figure 2: Manufacturing stamp

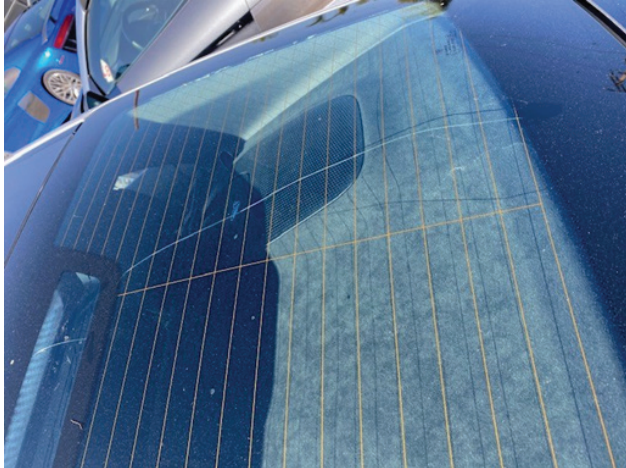
3. Overview of the rear window that clearly displays the crack

A crack can be seen on the inside surface of the rear window extending from the third brake light down to the bottom of the rear window glass. This condition is often noticed during the PDI.

Figure 3: Rear window overview
