## Mack Medium Duty Carrier Bearing Bolt Re-Torque

**Service Category** Service

**Section** function Group 451

#### MACK

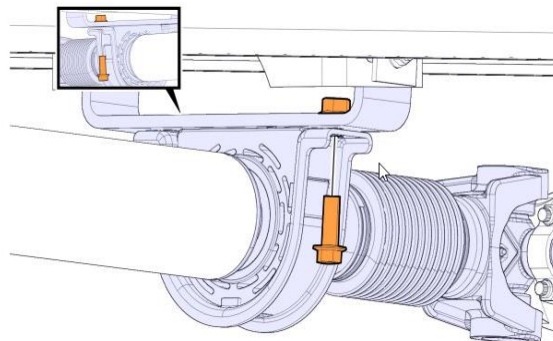
On certain Mack Medium Duty chassis, a possible under torque condition has been identified on the carrier bearing mounting bolts. Mack Trucks recommends these fasteners be removed, cleaned, and inspected. If the fasteners are found to be in satisfactory condition, the fasteners are to be reinstalled and torqued to specification. If the fasteners are found to be damaged, the fasteners are to be replaced and torqued to specification.

1. Secure truck for service.
2. Support drive shaft near the carrier bearing to prevent movement of the drive shaft.
3. With drive shaft supported, remove the fasteners that attach the carrier bearing to the carrier bearing support bracket.

4. Clean and Inspect the removed fasteners for reuse.
  - a. If fasteners are found to be damaged, replace fasteners and continue to step 5.
  - b. If no defects or damage is found in the fasteners proceed to step 5.
5. Ensure driveshaft is centered to carrier bearing bracket and Install fasteners.
6. Torque fasteners to proper specification of 175 Nm +/- 10 (129 +/- 7 lbf-ft)
7. Release truck for service.
