ID # CBR-2123-4

Volvo Chassis - Model VNR With RH Side Fairing Only - Heat/Splash Shield Loose, Possible DTC P204800 And/Or P204713

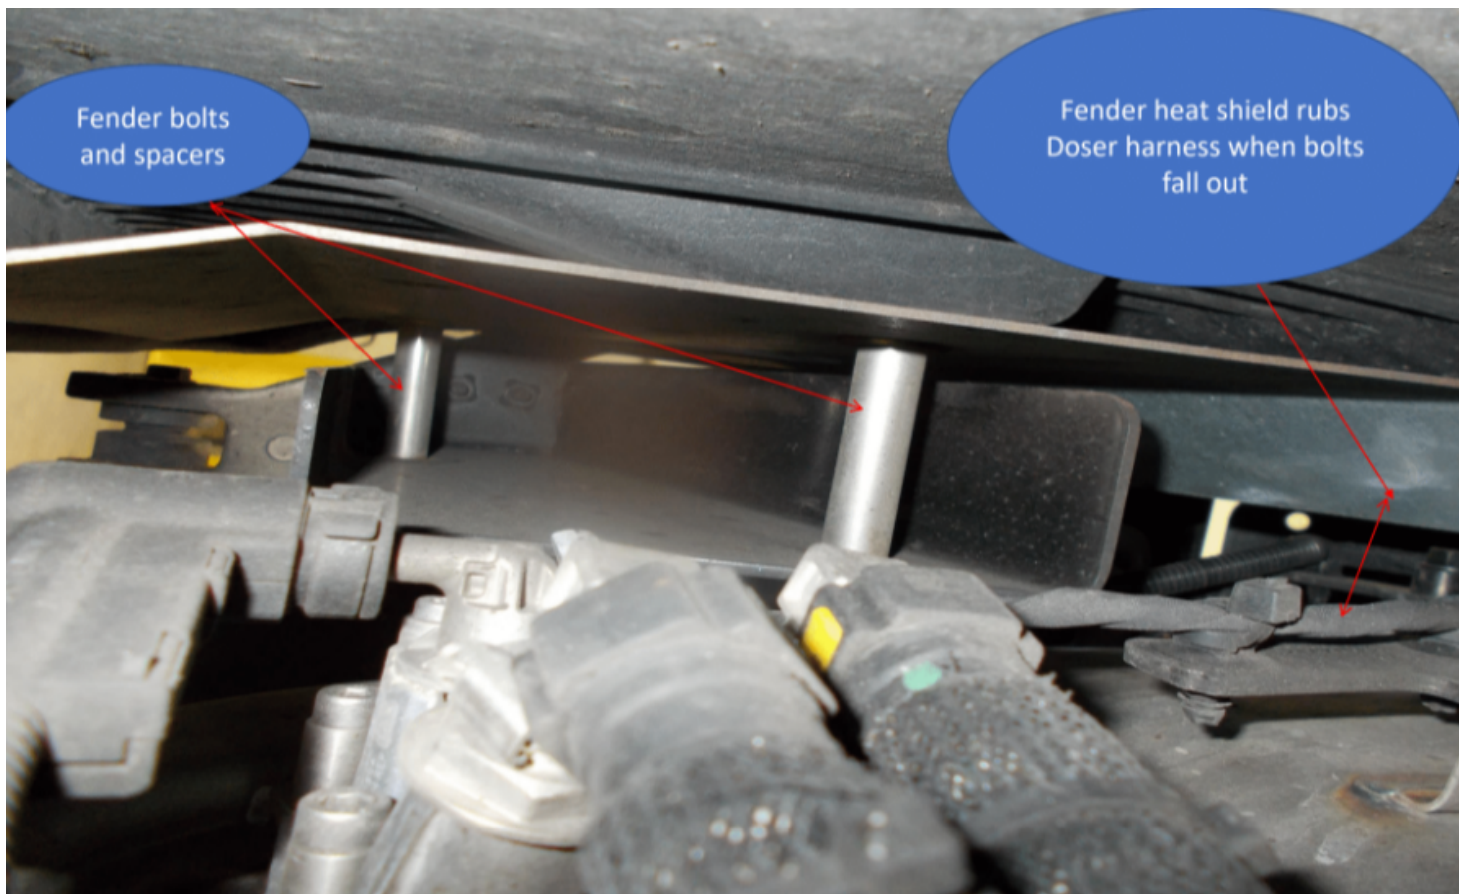
On certain Volvo VNR chassis equipped with a right-hand (passenger) side fairing, there is a possibility that the bolts securing the EATS heat shield/splash shield may become loose. This may lead the shield to rub on the EATS wiring harness, resulting in damage.

Diagnostic Trouble Codes (DTC) P204800 and P204713 may be observed as a result of the harness fatigue due to the loose shield.
