# 36-007: Incorrect blind spot sensor may have been installed on the right hand side in certain Model 579 vehicles

6/8/2021

36-007

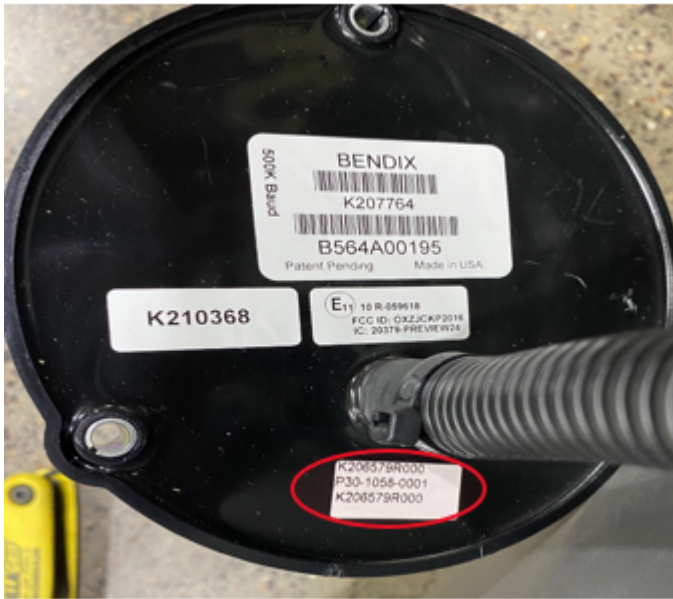
1. Locate the right hand blind spot sensor.

2. Inspect the sensor part number to determine if the correct sensor was installed. Correct sensor: K206579R000.
3. If a correct sensor is installed, no further action is required.

1. Remove the fairing if necessary.
2. Unplug the power from the sensor and remove three bolts holding the incorrect blind spot sensor.
3. Remove and replace the incorrect sensor with a new sensor and reinstall the three bolts.
4. Plug the power source to the sensor.
5. Reinstall the fairing.
