Reoccurring Diagnostic Trouble Code (DTC) P245700 Following EGR Cooler Cleaning Or Replacement

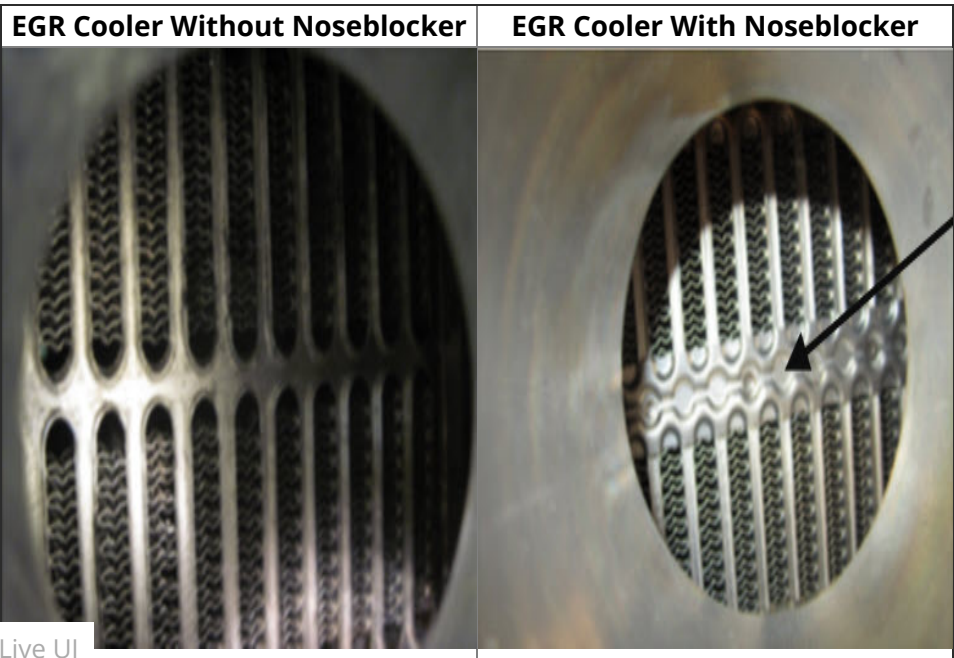
Some cases of recurring DTC P245700 EGR Cooler "A" Efficiency Below Threshold after installation of a cleaned EGR cooler can be caused by installation of an older design EGR cooler that allows for higher EGR outlet temperatures, even after cleaning at a radiator shop. The problem is that older (non-noseblocker) type coolers end up in the pool of EGR coolers and can be installed on newer trucks. The earlier design allows for higher EGR outlet temperatures, even after cleaning, which can trigger DTC P2457.

In addition to verifying the PN, a visual inspection of the cooler outlet will reveal if it is the newer "nose blocker" style or the older (not accepted) style. See chart below.

- All 11L EGR coolers have superseded to PN 22134240 - any earlier (lower numbered) PN should not be installed
- All 13L EGR coolers have superseded to PN 22134241
