Service Bulletin

Bulletin No.: 18-NA-279

Date: May, 2021

Subject: Information on Passive Door Unlocking Inoperative and/or Enabling and Disabling of Passive Unlocking

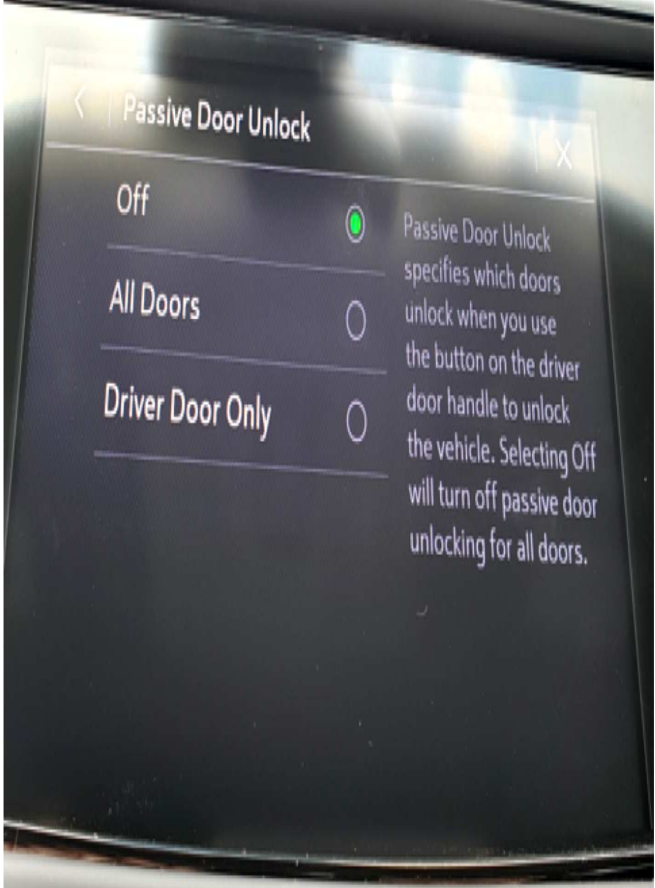
<p>Involved Region or Country</p>	<p>North America, Chile, Colombia, Ecuador, Peru, Europe, Israel, Middle East, Cadillac Korea (South Korea), GM Korea Company, Uzbekistan, China, Japan, Malaysia, Vietnam</p>
<p>Condition</p>	<p>Some customers may comment that the passive door unlocking feature is inoperative when pressing the button on any door handle or tailgate release handle. They may also comment that all turn signals flash 4 times quickly when the button is pressed.</p>
<p>Correction</p>	<p>When using the following procedures, the owner can cycle between Passive Unlocking Enabled to Passive Unlocking Disabled, and back.</p> <p>Once any individual FOB is used to disable Passive Unlocking, Passive Unlocking will be disabled for ALL FOBs.</p> <p>Additionally, as shown below, some listed vehicles have "Passive Door Unlock" as a Vehicle personalization feature via the center stack. When selected, this option applies to ALL FOBs.</p>

Starting State	Do:	Results in:
Passive Unlocking is Enabled	Press and Hold both Lock and Unlock FOB buttons for 3 seconds.	Turn Signals flash 4 times and Passive Unlocking is Disabled. When the button on the door handle is pressed, the Turn Signals flash 4 times and the doors remain locked.
Passive Unlocking is Disabled	Press and Hold both Lock and Unlock FOB buttons for 3 seconds.	Turn Signals flash 2 times and Passive Unlocking is Enabled. When the button on the door handle is pressed, the door(s) will unlock.
