Service Bulletin

Bulletin No.: 20-NA-178

Subject: Service Driver Assist and/or Take Steering Messages on Start-up, Advanced Driver Assist Systems (ADAS) Features Not Available

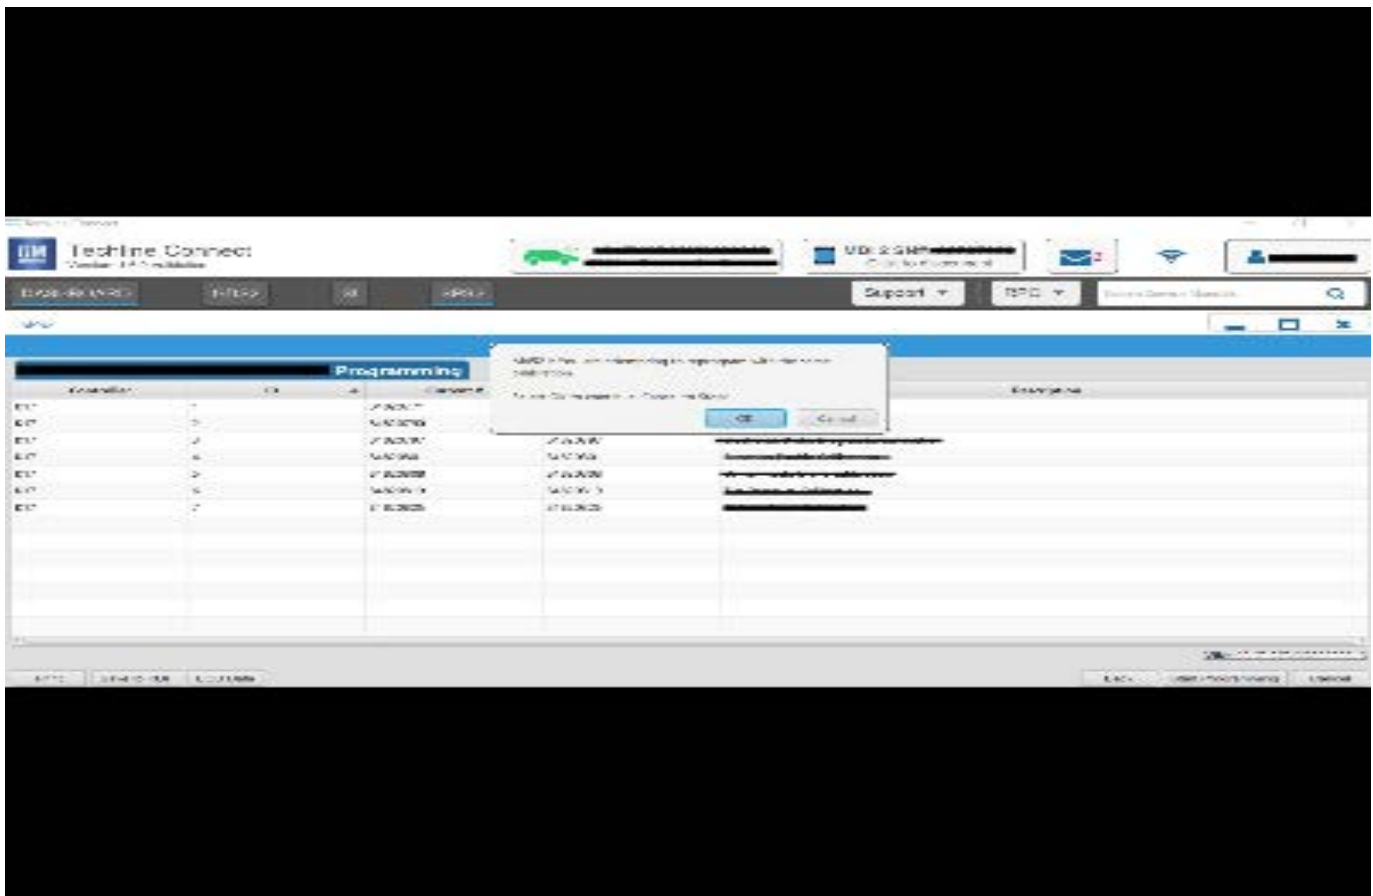
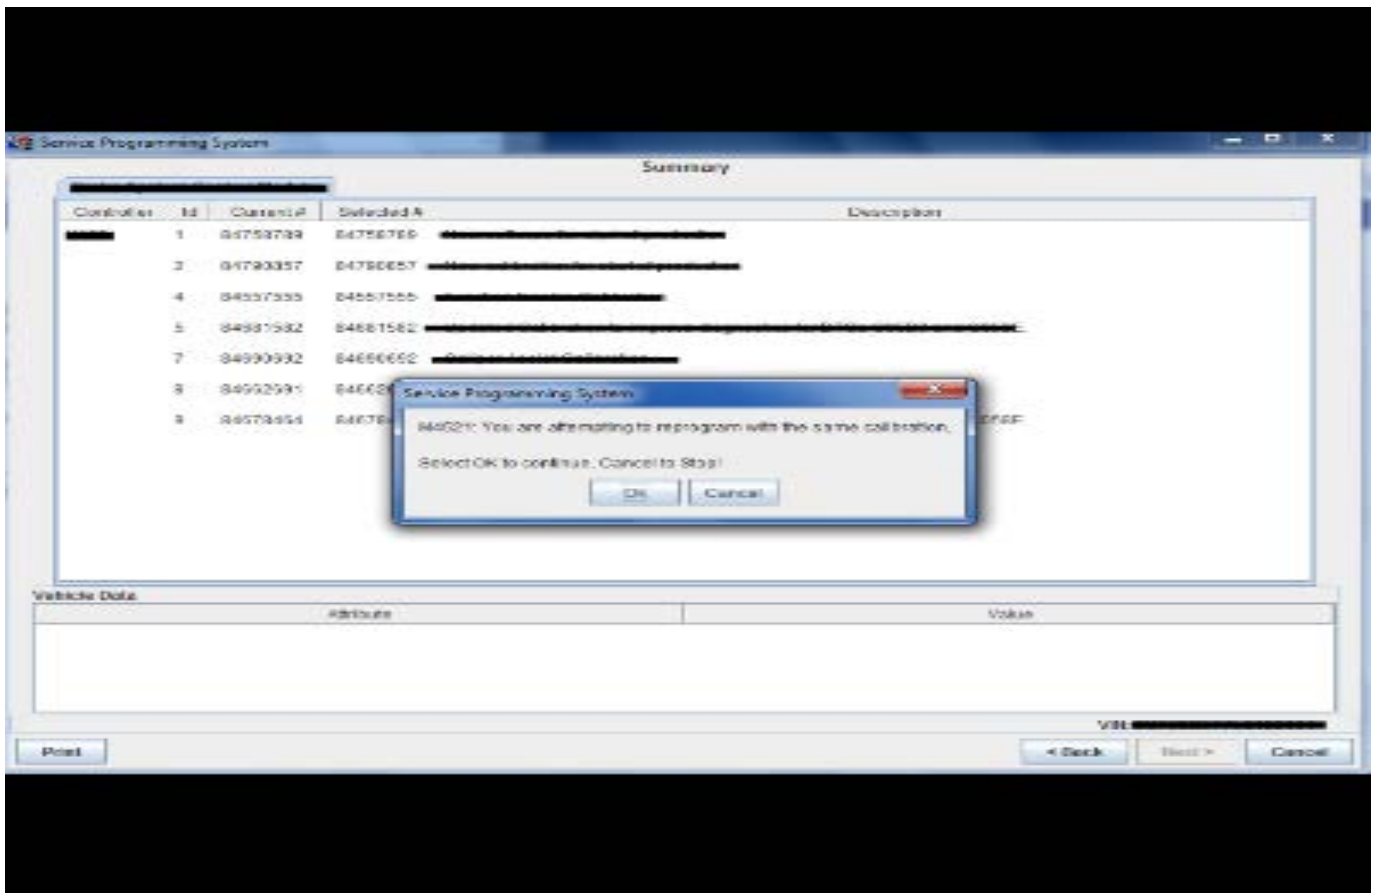
Caution: Be sure the VIN selected in the drop down menu (1) is the same as the vehicle connected (2) before beginning programming.
