Service Bulletin

Bulletin No.: 20-NA-219

Subject: Gurgle or Sloshing Noise Heard Coming from Front Sunroof Drain Hose Areas

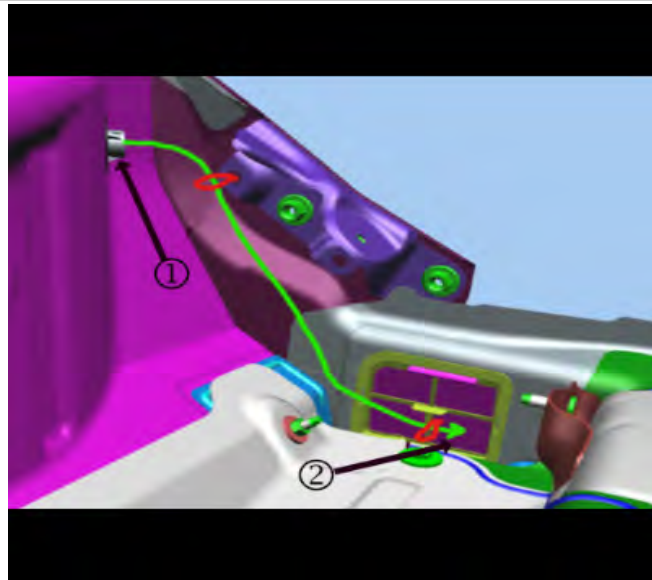
5677469

Note: An illustration of the driver side hose is shown in the graphic above.

Following the steps in the Service Procedure below, add drain hose extensions to both the right and left sides. These extension hoses will attach to the existing sunroof front drain hose grommets (1) in the plenum and then exit out the plenum drain valve (2), on that side of the vehicle.

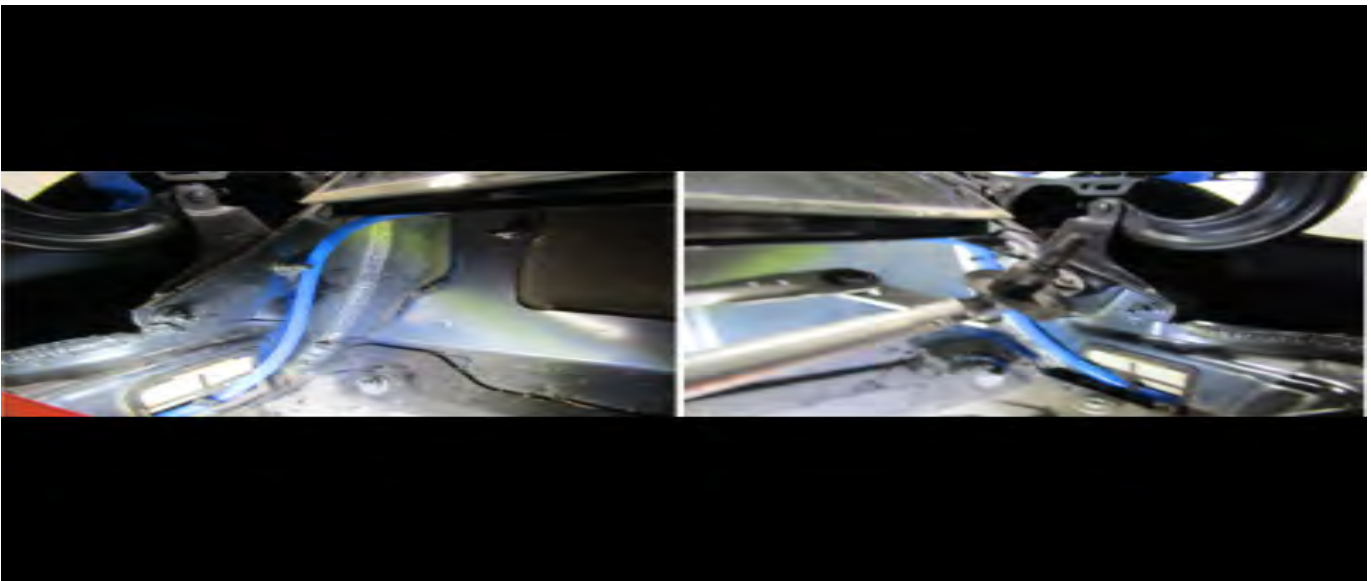
5677480

Note: The graphic above shows the hose installation completed on both the passenger and driver sides.
