Service Bulletin

Bulletin No.: 21-NA-094

Subject: Hood Ajar Message Displayed on Driver Information Center (DIC), Hood May Not Open Using Any Electrical Release Buttons, But Will Open Using Manual Release Cable

Brand:	Model:	Model Year:		VIN:		Engine:	Transmission:
		from	to	from	to		
Chevrolet	Corvette	2020	2021	—	—	All	All

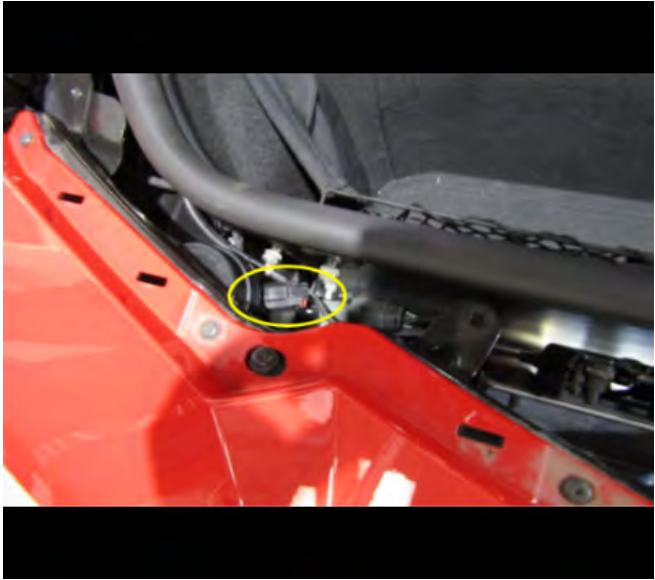
5795580

Involved Region or Country	North America, Middle East, Japan
Condition	Some customers may comment on a hood ajar message displayed on the DIC. The hood may not open using any of the electrical release buttons but will open using manual release cable.
Cause

- Possible water intrusion and terminal corrosion into connector X103.
- Water intrusion into the hood latch actuator itself.
- Failure of the auxiliary hood latch release switch.
