Service Bulletin

Bulletin No.: 21-NA-118

Subject: Vibration Type Noise Heard at Highway Speeds or with Engine Speed at 1,300-1,500 RPM

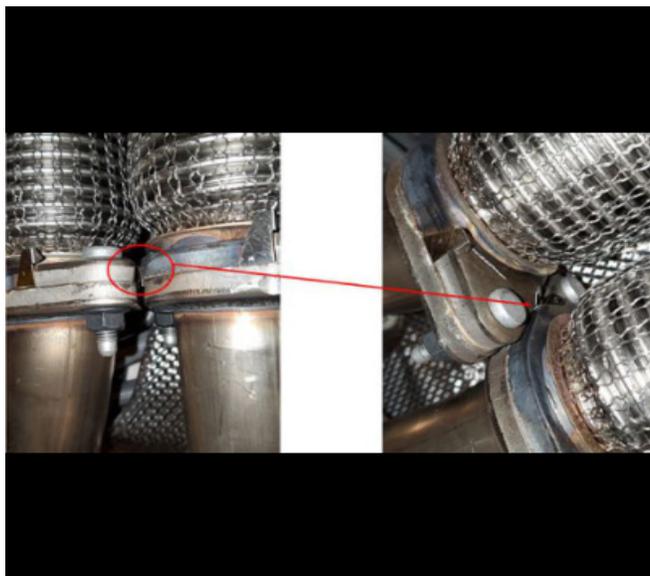
5776432

Involved Region or Country	North America, Russia, Middle East, Israel, Palestine, Chile, Columbia, Ecuador, Peru, Japan, S. Korea, Australia and New Zealand.
Condition	Some customers may comment on a vibration type noise at highway speeds and/or with Engine Speed at 1,300-1,500 RPM. The sound can usually be heard from under the vehicle.
Cause	The cause of the condition may be due to some of the metal gasket tabs between the front exhaust and muffler not being fully crimped, exhibiting some spring-back, allowing for them to touch at certain speeds / RPMs.
Correction	Refer to the procedure below to correct the condition stated above.

With a small punch or chisel and hammer bend/crimp the tabs on the exhaust gasket in further to prevent any spring-back and provide increased clearance between the two tabs to correct the noise or cutting the tabs off the gaskets is also acceptable.
