## SIB 51 11 21 ROOF TRIM STRIP LOOSE AT REAR

2021-05-19

E-Series	Model Description	Production Date
G82	M4 Coupe	November 12, 2020- May 28, 2021

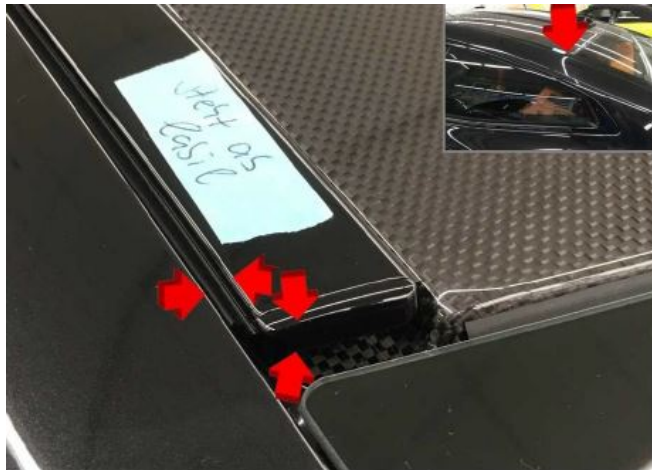
The roof trim strip may be loose at the last (rearmost) clip as shown.

This can occur on either side of the roof, or on both sides.

Tension on the roof strip caused by a foam support block.

Remove the foam block and reinstall the roof trim strip.
