SIB 61 06 21

DELIVERY STOP: CHARGING CABLE (NON-TURBOCORD VERSION)

This Service Information Bulletin (Revision 2) replaces SI B61 06 21 dated May 3, 2021.

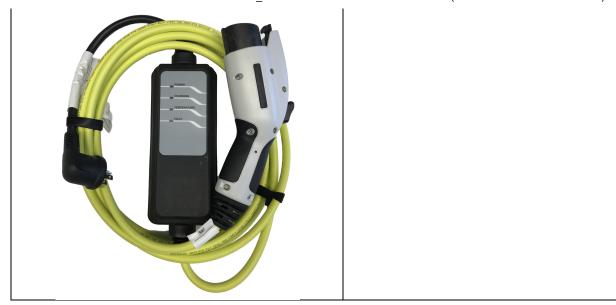
The vehicle cannot be charged on Level 1 because the Occasional Use Charging Cable (Standard OUC/Level 1/Mode 2), may have not been included.

CAUSE

Provide (insert/put in the vehicle) the OUC.

Note: If the vehicle is already equipped with this charger, no action is required.
