Complaint – "Reduced Engine Power" Message in Instrument Cluster: Checking Ground Points (73/21)

Model Line: **Panamera (971)**

Model Year: **As of 2017 up to 2020**

Concerns: **Electric fan**

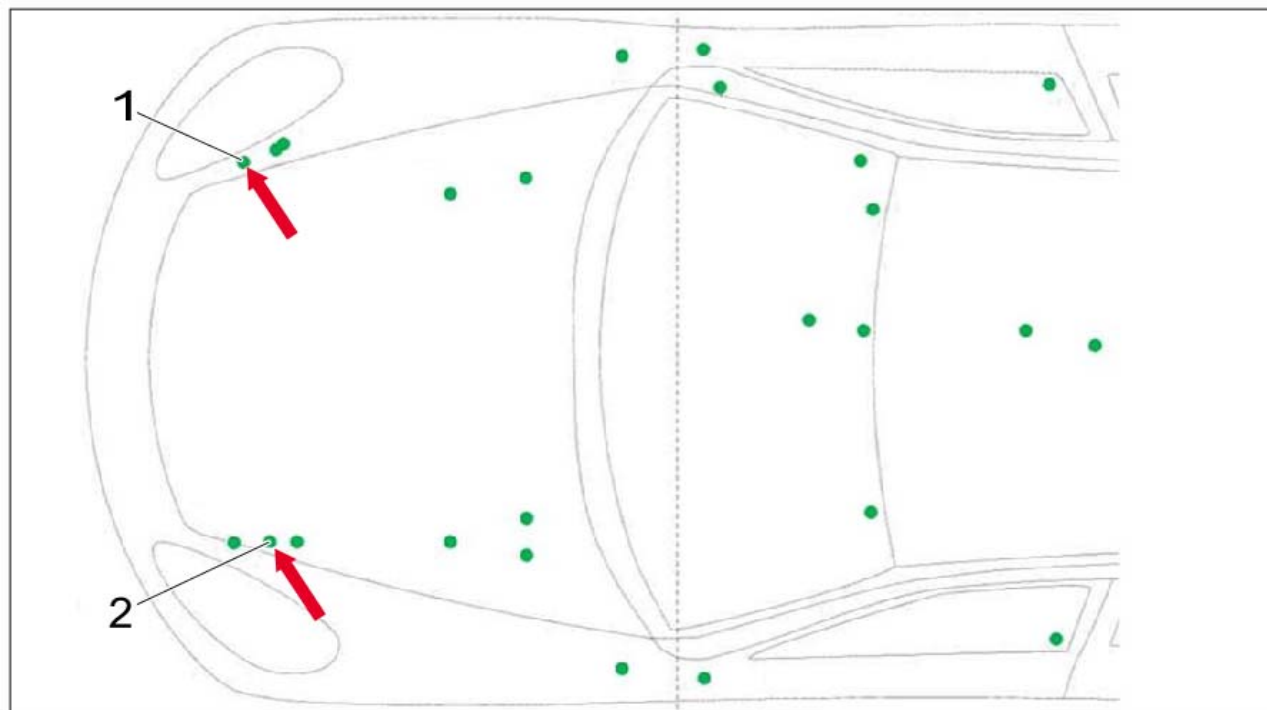
Overview of ground points

The reason for this may be insufficient contact at one or both of the affected ground points ⇒ *Overview of ground points -1 and 2-* of the electric fan.

Action required: Expose ground points, check them and remove any non-metallic residues.
