WME1 - Adjusting Steering Wheel Position (Workshop Campaign)

Model Year: 2021

Model Line: Cayenne (9YA/9YB)

Concerns: Electric steering column adjustment (M-no. 2C7)

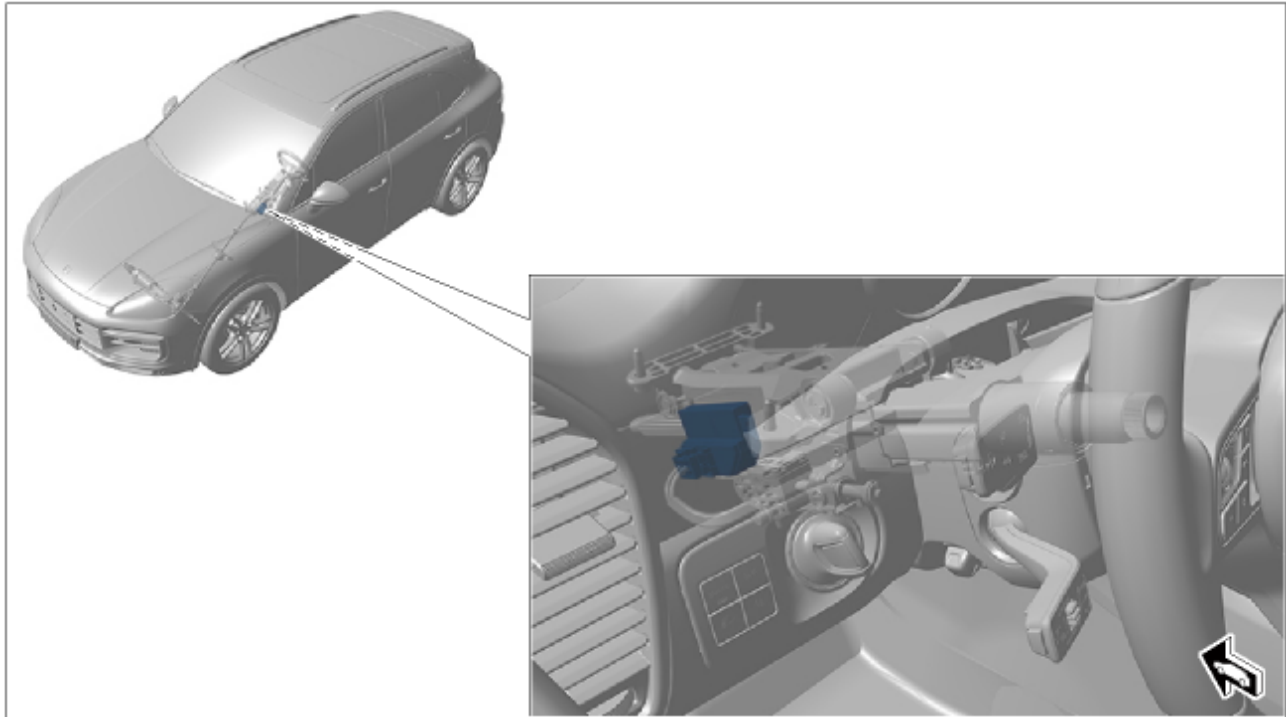
Installation position of control unit for steering column adjustment

To adjust the steering wheel position, the control unit for the steering column adjustment must be installed temporarily beforehand. One control unit will be provided for each Porsche dealer for this purpose.

The control unit provided with the part number V04015953K must be re-used as part of the workshop equipment and remains at the Porsche dealer. The control unit must not therefore be left in the vehicle and must be removed again after adjusting the steering wheel position.

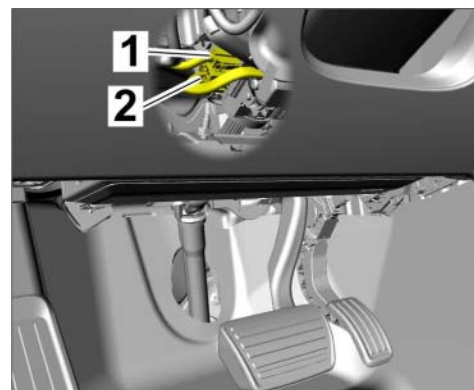
Connecting lines for control unit for steering column adjustment

- 3 Remove dashboard cover (on driver side). ⇒ *Workshop Manual '70221901 Removing and installing dashboard cover (driver side)'*
- 4 Connect the two free connecting lines ⇒ *Connecting lines for control unit for steering column adjustment -1 and 2-* to the control unit for steering column adjustment.

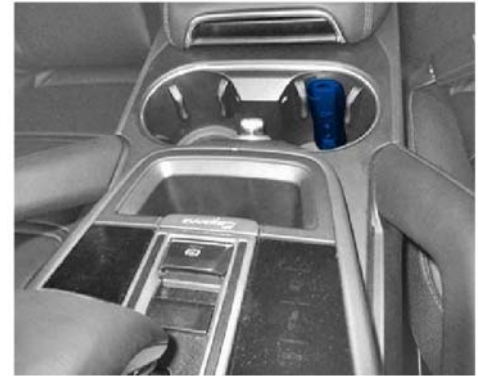
Emergency start tray

- 10.2 **Position** the driver key in the rear area of the left cupholder in the center console between the holding struts (emergency start tray) in order to guarantee a permanent radio link between the vehicle and driver key ⇒ *Emergency start tray*.
- 10.3 Connect **9900 - PIWIS Tester 3** to the vehicle communication module (VCI) via the **USB cable**. Then connect the communication module to the vehicle and switch on the PIWIS Tester.

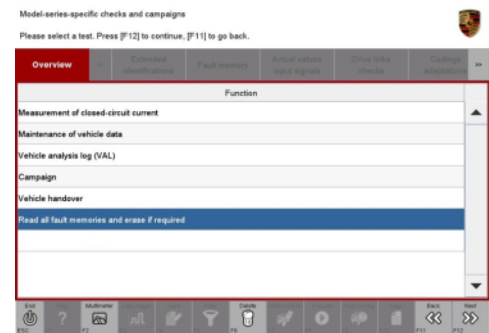
Erasing fault memories

Due to the lack of a control unit for steering column adjustment, the fault **0x01025A (U113E00) "Control unit for electrically adjustable steering column, no communication"** is stored in the fault memory. **This fault must be ignored in this case**, until the follow-up campaign **WME2** to install the control unit for steering column adjustment is published when the parts are available.

- 10.4 Switch on the ignition and open the '**Diagnos**tics' application on the PIWIS Tester start screen.
- 10.5 Press **•F7** in the control unit selection screen ('Overview' menu) to call up the Additional menu.
- 10.6 Select the function "Read all fault memories and erase if required" and press **•F12** ('Next') to confirm ⇒ *Erasing fault memories*.

- 10.8 Press **•F8** to delete fault memory entries.
- 10.9 Press **•F12** ('Yes') in response to the question as to whether you really want to delete all fault memory entries.

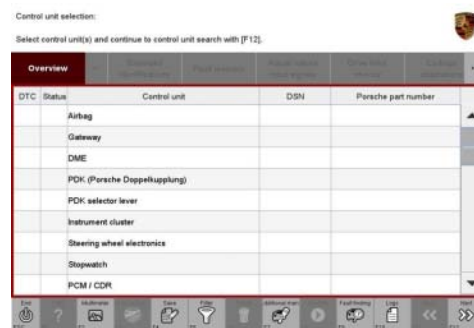
Control unit selection

10.10 Once you have erased the fault memories, select the **'Overview'** menu to return to the control unit selection screen ⇒ *Control unit selection*.
