MODEL
2020MY
Rio (SC) w/IVT

NUMBER
097 (Rev 1, 07/02/2021)

TECHNICAL SERVICE BULLETIN

SUBJECT: **SERVICE ACTION: IVT/CVT SW LOGIC IMPROVEMENT
AND/OR IVT/CVT REPLACEMENT (SA476)**

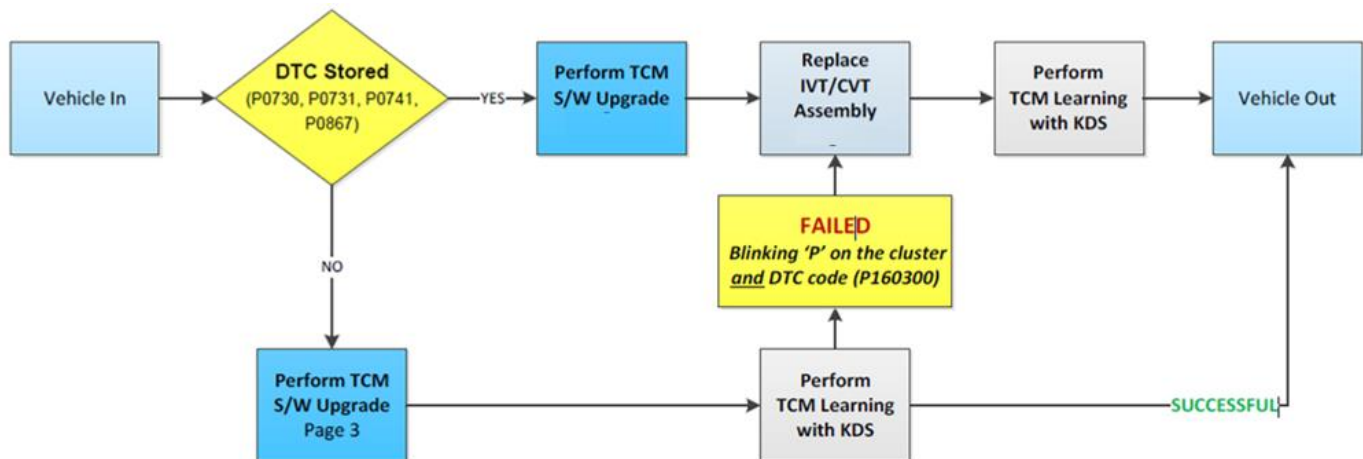
Flowchart:

- 1) Using the KDS (connected to the internet to create and transmit a VDN*), perform a Fault Code Search and confirm DTC P0730, P0731, P0741 or P0867 is/are stored (Active, History or Pending). Follow the flow chart above and perform the necessary procedure(s).

- 2) If one of the four DTCs (P0730, P0731, P0741, P0867) applies during the DTC Check, upgrade the TCM S/W and replace the IVT/CVT.
- 3) Replace the IVT/CVT according to the applicable Shop Manual on KGIS.

- 4) Then perform the IVT/CVT resetting auto T/A values, oil-pressure characteristics input, TCM adaptive values learning procedure.
- 5) If DTCs P0730, P0731, P0741, and P0867 do not come back, upgrade the TCM S/W and perform TCM adaptive values learning procedure. If successful, complete the service. If not, and TCM Learning fails, 'P' will be blinking on instrument cluster and DTC code P160300 will set. Then replace the IVT/CVT and do TCM Learning again.
