## Tips & Tricks – All Models

no.	Symptom	Subject	Photo	Notes and Indications - Corrective action
1	<p><u>ONLY</u> <u>Monster 821</u> <u>Monster 1200</u> <u>SuperSport</u></p> <p>Possible engine popping sound during deceleration and/or irregular idling</p>	Airbox

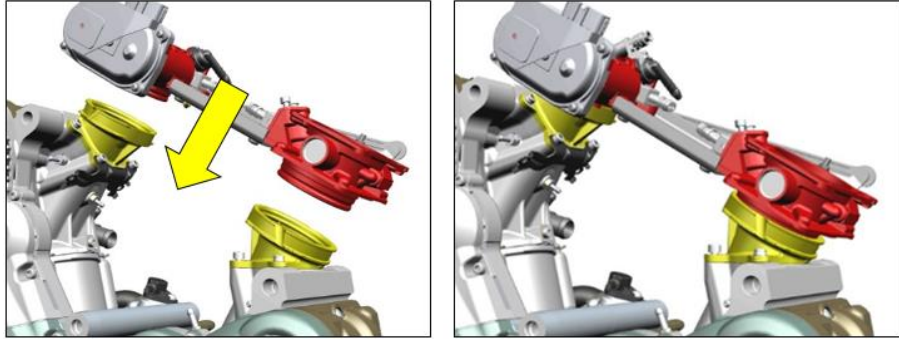
<p>We have received some complaints about a possible engine popping sound during deceleration. The performed analyses have shown that this symptom could be caused by an incorrect installation of the throttle bodies in the relevant intake manifolds (possible deformation of the rubber profile).</p> <p>Therefore, if you find any similar symptoms, we kindly ask you to check the correct installation of the Airbox on the motorcycle and that:</p> <ul style="list-style-type: none"><li>- throttle bodies are correctly inserted inside rubber intake manifolds, along the whole perimeter;</li><li>- the rubber profile of the intake manifolds is not deformed.</li><li>- the 2 fastening ties are correctly positioned in the seat on the intake manifolds.</li></ul> <p>Please be reminded that, to make throttle body insertion easier on rubber intake manifolds, the use of silicone lubricant or similar product is absolutely necessary.</p>

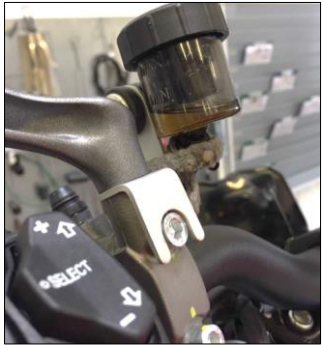
no.	Symptom	Subject	Photo	Notes and Indications - Corrective action
7	<p><u>ONLY</u> <u>models equipped with</u> <u>hydraulically controlled</u> <u>clutch lever</u></p> <p>Possible reduction of the clutch fluid level inside its reservoir</p>	Hydraulic clutch control

<p>We received a few claims concerning a reduction of the clutch fluid level inside its reservoir. We would like to inform you that it is not sufficient to carry out the bleeding procedure or top up the clutch fluid inside the reservoir. We suggest, at a preliminary stage, to check:</p> <ul style="list-style-type: none"><li>• the play between the clutch master cylinder and the lever</li><li>• if the clutch pushrod is worn or damaged in the area of contact with the clutch slave cylinder (ball)</li><li>• the condition of the clutch slave cylinder protective diaphragm, which must not be torn.</li></ul> <p>According to our analyses, this phenomenon is due to a DOT4 leakage from the primary seal of the clutch slave cylinder (missing fluid in the reservoir builds up in-between the clutch slave cylinder diaphragms); in some cases, this phenomenon is also accompanied by wear of the clutch pushrod. We therefore ask you to replace the slave cylinder with a new <b>part no. 19540091D</b> featuring a new gasket in order to prevent the phenomenon described above.</p> <p>If the clutch pushrod is damaged as shown in the figure, replace it as well.</p> <div data-bbox="1256 727 1995 1007">

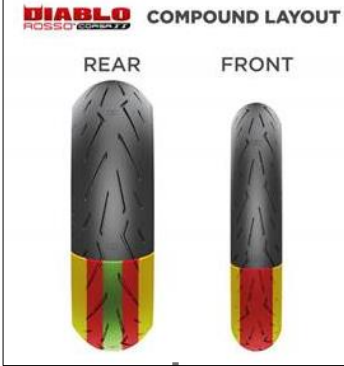
9	<p>Possible formation of a well-marked "band" in correspondence with the central area of the Pirelli Diablo Rosso Corsa II rear tire</p>	<p>Pirelli Diablo Rosso Corsa II rear tire</p>

<p>We have received some isolated reports of the appearance of a "band" in correspondence with the central area of the Pirelli Diablo Rosso Corsa II rear tire.</p> <p>We would like to inform you that, since these are extremely sporty tires with 5 different compound zones at the rear, it can happen that, depending on the type of use of the motorcycle, they wear out in a different way causing the above mentioned phenomenon to occur; sometimes this occurs on the shoulder area, sometimes in the central area but, in general, it is a purely aesthetic phenomenon that does not affect the performance of the tire itself.</p>

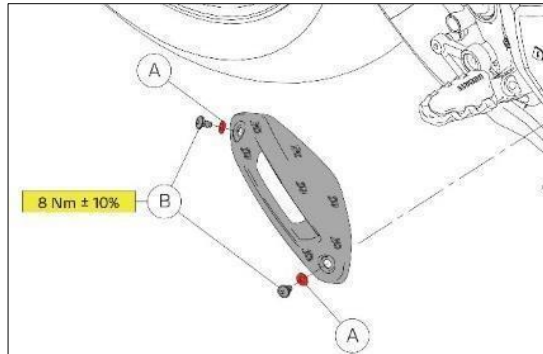
2	Update of the assembly instructions for the carbon horizontal manifold heat guard kit part no. <b>96980251A</b>	carbon horizontal manifold heat guard kit part no. <b>96980251A</b>

<p>We inform you that the assembly instructions for the carbon horizontal manifold heat guard kit by Ducati Performance part no. 96980251A have been updated. In particular, in order to install the part, <u>you must reuse the 2 washers (A) present on the original heat guard.</u></p> <p>Please always comply with the tightening torque of the 2 screws M6x12 (B) of <b>8 Nm ± 10%.</b></p>

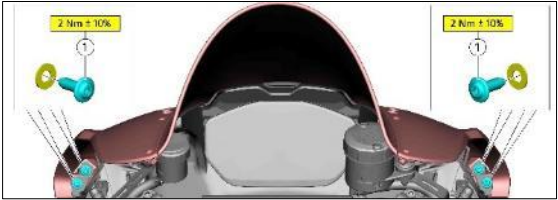
no.	Symptom	Subject	Photo	Notes and Indications - Corrective action
1	<p><u>ONLY</u> <u>Panigale V2</u></p> <p>Precautions during PDI: installation of the side half-fairings</p>	Side half fairings

<p>We received some isolated claims about the possible breakage of the top fastener retaining the LH side half-fairing to the headlight fairing.</p> <p>During PDI and whenever removing the side half-fairings, we remind you to pay utmost attention to the tightening of the <b>2 screws M5x0.8 (1)</b> retaining the upper LH and RH half-fairings to the headlight fairing; always comply with the specified tightening torque of <b>2 Nm ± 10%</b>.</p>

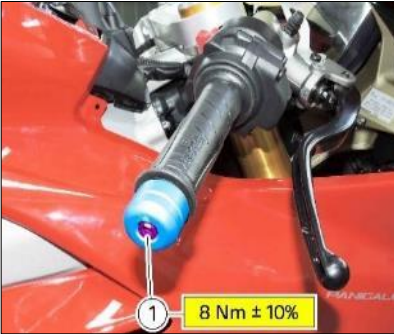
2	<p><u>ONLY</u> <u>Panigale V4</u></p> <p>Precautions during PDI: installation of the balancing weights on the handlebar</p>	Handlebar counterweights

<p>We received some isolated claims about the possible triggering of a longitudinal crack on the handlebar, on balancing weight side. Our laboratory analyses found that said crack is due to an excessive tightening torque applied when installing the balancing weights.</p> <p>When installing balancing weights on the handlebar, please comply with the tightening torque specified for the M6x55 screw of <b>8 Nm ± 10%</b>, as indicated on the bulletin introducing the model and on the Workshop Manual.</p>

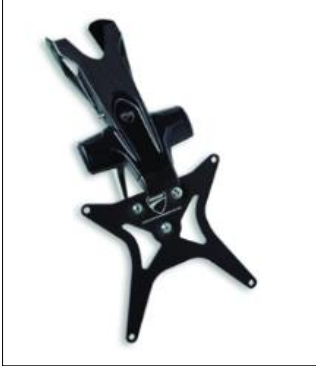
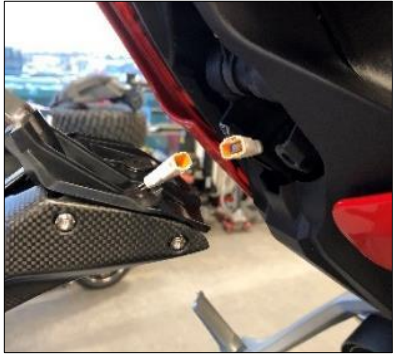
3	<p><u>ONLY</u> <u>Panigale V4</u> <u>(all versions)</u> <u>Panigale V2</u></p> <p>Assembly precautions for Carbon number plate holder kit <b>part no. 97380921A</b></p>	Carbon number plate holder kit <b>part no. 97380921A</b>

<p>We kindly inform you that <u>ONLY</u> when installing the carbon number plate holder kit part no. 97380921A to a Panigale V2 model, it is necessary to purchase wiring <b>part no. 5101H931A</b> to connect the number plate holder connector to motorcycle rear wiring harness connector.</p> <p>We also inform you that the new carbon number plate holder kit <b>part no. 97381161AA</b> is now available. It is specific for Panigale V2 and Streetfighter V4 and will include the above-mentioned wiring.</p>

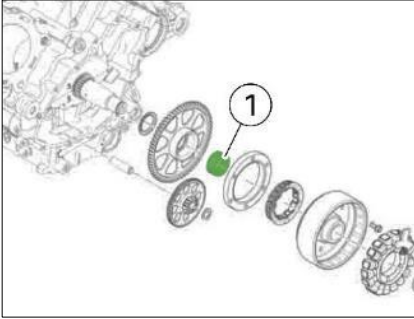
no.	Symptom	Subject	Photo	Notes and Indications - Corrective action
4	<p><u>ONLY</u> <b>Panigale V4</b></p> <p>Starting system update</p>	Starting system	-	<p>To ensure a better starting operation of the engine, we inform you that from engine serial number:</p> <ul style="list-style-type: none"> <li>- ZDM1100W4#<b>007612</b># for EUR version,</li> <li>- AGNK<b>007652</b> for CAL version,</li> </ul> <p>the <b>roller bearing (1)</b> has been introduced instead of the bushing.</p> <p>Please, note that the spare part catalogue has been updated.</p>

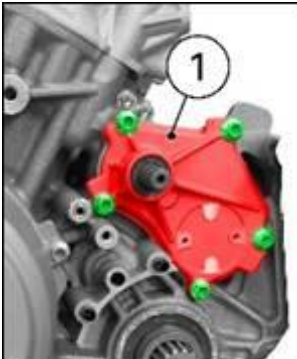
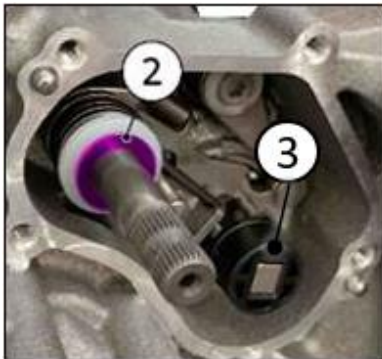
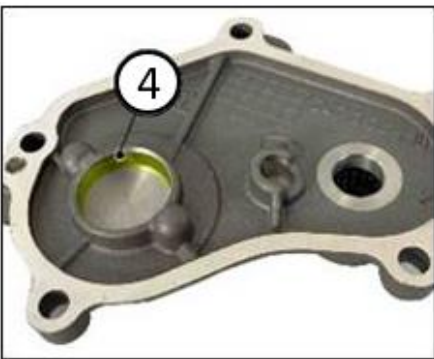
no.	Symptom	Subject	Photo	Notes and Indications - Corrective action
11	<p style="text-align: center;"><u>ONLY</u> <b>959 Panigale</b> <b>(all versions)</b></p> <p>Possible hardening of gear shift control with difficulty in shifting gears when hot</p>	Gear selector	-	<p>We have received some isolated reports about a possible hardening of the gear shift when hot with consequent difficult selection of gear ratios. Based on the analyses carried out, this phenomenon could be due to a hardening between the gearbox sensor magnet plastic support and the relevant seat inside the cover.</p> <p>You are kindly asked to carry out the following operations:</p> <ol style="list-style-type: none"> <li>1) Remove the <b>gear shift cover (1)</b> on motorcycle LH side;</li> <li>2) Check for the presence of <b>shim (2)</b>;</li> <li>3) Mill the end face of the plastic cage for the selector magnet (3) shorter by 0.1 mm maximum and the outer curved edge where it enters the bore of the cover by 0.1 mm maximum, <u>or</u> mill the internal <b>surface (4)</b> of the cover highlighted in the figure and remove 0.1 mm maximum of material from the end and bore of the recess. Ensure the orientation of the magnet is not changed on the shift selector or the gear position will not be able to be determined by the sensor.</li> </ol> <div style="display: flex; justify-content: space-around; margin-top: 10px;">

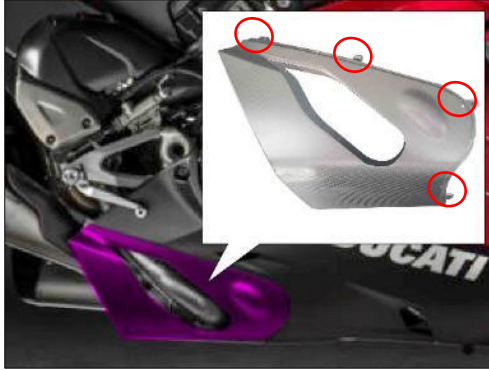
<p>We have received some isolated reports about an incorrect coupling between the silencer covers and the side half fairings in case the complete Akrapovic racing titanium exhaust system, supplied with the motorcycle, is installed. In fact, it is possible to find a misalignment between the mounting holes of the components.</p> <p>To improve this coupling, it is possible to slot-drill the 4 mounting holes of the silencer covers by using a column drill with a <u>6 mm drill bit</u> and setting a high rotation speed to prevent the fiber from flaking off.</p>

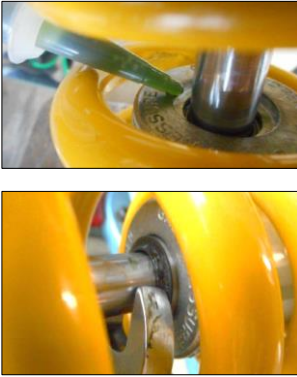
14	<p><u>ONLY Panigale V2</u></p> <p>Possible popping out of the dust seal on the Sachs rear shock absorber buffer support plug</p>	Sachs rear shock absorber

<p>We have received some isolated reports about the possible popping out of the dust seal on the rear shock absorber buffer support plug. <u>Do NOT replace the rear shock absorber.</u></p> <p>To avoid the phenomenon described above it is necessary to:</p> <ul style="list-style-type: none"> <li>- apply a few drops of <b>LOCTITE 638</b> on the plug, at the dust seal seat;</li> <li>- place the dust seal on the plug using an open-end wrench and hold it for a few seconds;</li> <li>- carefully clean any residues of LOCTITE 638 that may have fallen accidentally on the rod and on any other surface.</li> </ul> <p>Please note that the supplier, Sachs, has introduced LOCTITE 638 during the assembly stage from <u>week 29-2020</u> (this information can be found on the sticker on the shock absorber body).</p>

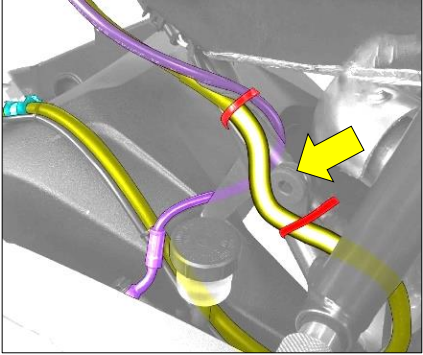
no.	Symptom	Subject	Photo	Notes and Indications - Corrective action				
1	<p><u>ONLY Scrambler 800 (all model versions and MY, excluding Desert Sled model version)</u></p> <p>Precautions when routing the rear brake caliper hose</p>	Rear brake hose	-	<p>We have found that sometimes, during maintenance operations, the rear brake caliper hose is not correctly positioned along the frame due to incorrect installation by the technician during service.</p> <p>Make sure that the rear brake caliper hose (yellow), passes outside the left side cover mounting bracket with respect to the motorcycle centerline and is fixed with the two self-locking ties (red) as shown in the figure.</p> <p>The operation of inspection and possible repositioning is very simple and involves the disassembly of the left side cover only.</p>

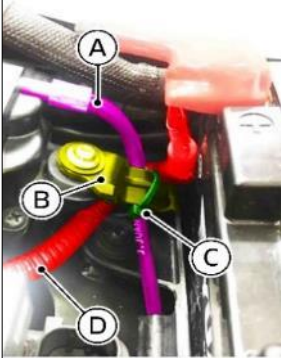
4	<p><u>ONLY</u>  <u>Scrambler 1100</u>  <u>Model Year 2020</u>  <u>(all model versions)</u></p> <p>Precautions during PDI: installation of the battery on the vehicle</p>	Battery assembly	-	<p>During the installation of the battery on the vehicle and, in any case, when the motorcycle first comes to the workshop for a service, we ask you to always check the correct positioning of the <b>exhaust butterfly valve cable (A)</b> under the <b>retainer (B)</b> and the presence of the <b>self-locking tie (C)</b>.</p> <p>Make sure the <b>motorcycle positive cable (D)</b> is positioned under the <b>exhaust butterfly valve cable (A)</b>.</p>

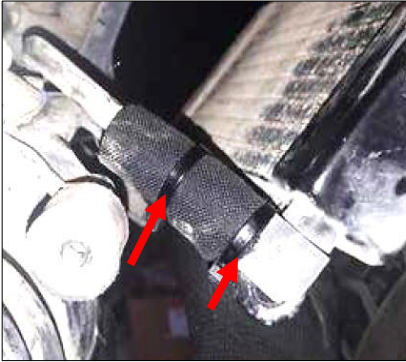
5	<p><u>ONLY</u>  <u>Scrambler 1100 PRO</u>  <u>(all versions)</u></p> <p>Irregular operation at idle speed and engine power loss</p>	Vertical cylinder LH spark plug cable	-	<p>As a result of continuous quality tests on the product, we have found a possible irregular operation at idle speed and engine power loss. This phenomenon is due to a settling of the vertical cylinder LH spark plug cable on the coil caused by the contact with the fitting of the oil return pipe from cooler (visible on motorcycle RH side). The MIL light does not come on.</p> <p>We ask you to always check the conditions of vertical cylinder LH spark plug cable and to apply the protective sheath Part no. 4601C581A (cut in half and secured in place with two small self-locking ties) on the fitting of the oil return pipe from cooler to avoid the above-described phenomenon.</p>

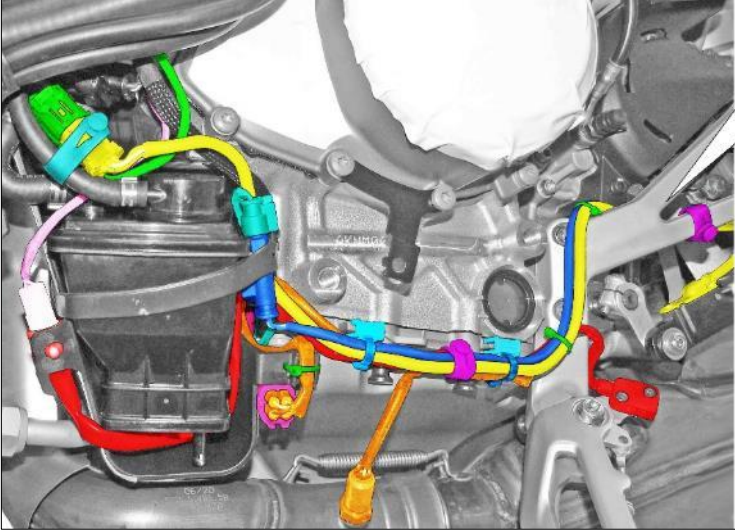
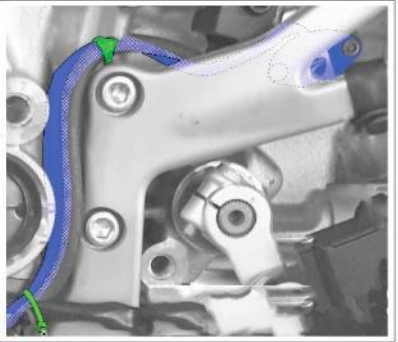
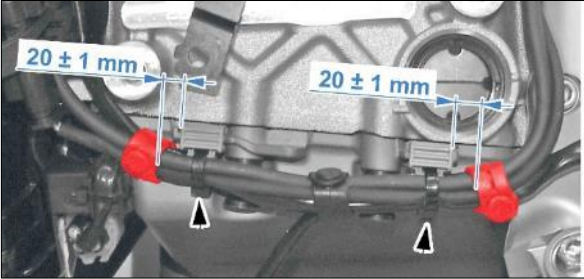
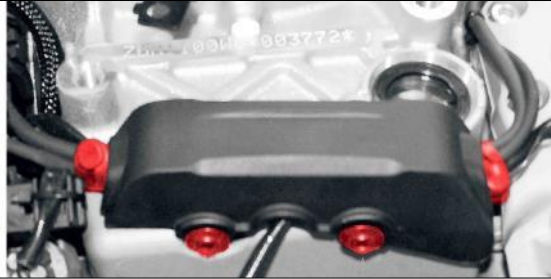
no.	Symptom	Subject	Photo	Notes and Indications - Corrective action
1	Updated layout of motorcycle wiring	Wiring	-	<p>We would like to inform you that the layout of the side stand cable - gear sensor cable - Ducati Quick Shift cable - lambda sensor cable and of the gear sensor connector and cable at the lower crankcase, on the left side of the motorcycle (as shown in the figure) has been updated starting from frame number ZDMFA00AALB003932.</p>

<p>Before installing the wiring cover, apply two L=39mm button ties respecting the dimensions shown in the figure:</p>

<p>We ask you to respect the new layout of the cables and the gear sensor connector in case of servicing of the mentioned parts.</p>

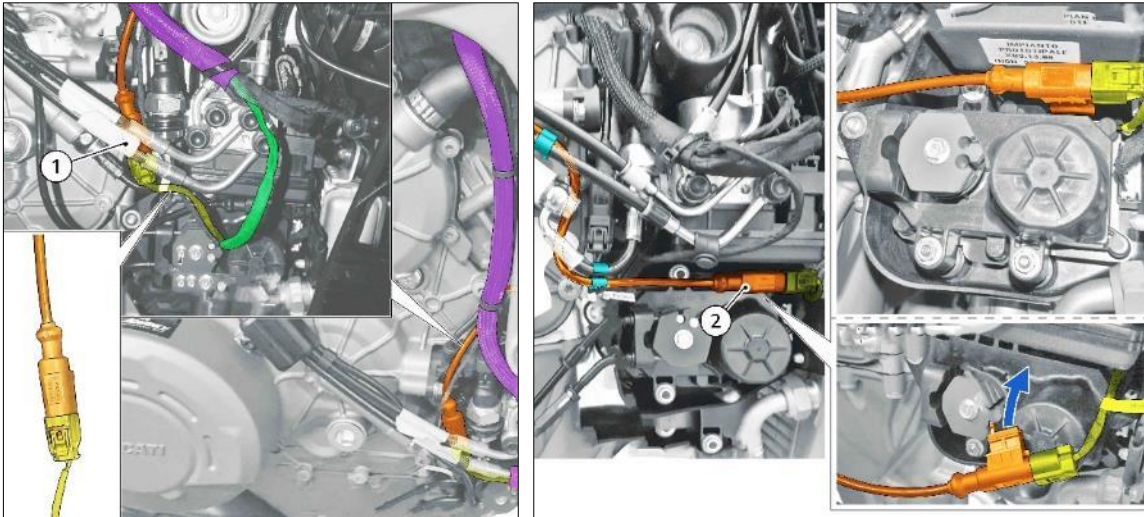
<p>We have received some isolated reports of vehicle speed limitation at values below 50 km/h due to the excessive traction control (DTC) intervention resulting from the installation of the complete titanium exhaust system part no. 96481652AA. The performed analyses have shown that the front and rear speed sensor connections were reversed.</p> <p><u>In case of interventions on the <b>front (1) and rear (2) speed sensor connectors</b>, please take the utmost care to their assembly, as shown in the figure, making sure not to reverse the connections.</u></p>

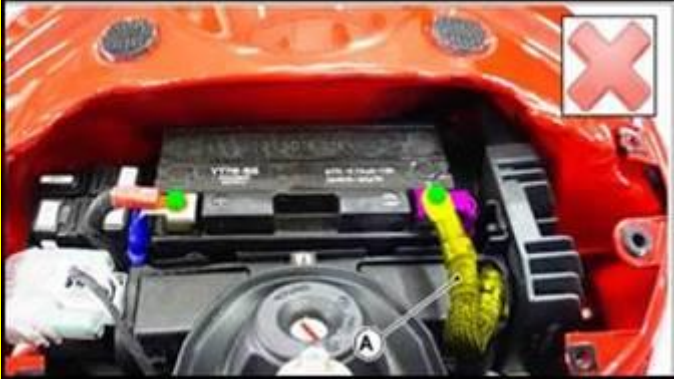
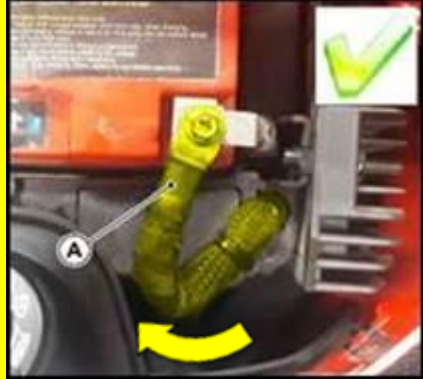
no.	Symptom	Subject	Photo	Notes and Indications - Corrective action
7	Update of pre-delivery operations: Battery assembly	Battery assembly

<p>We have received isolated reports of possible interference between the battery negative cable and the battery cover (in particular, the pin fixing the mesh to the cover).</p> <p>We inform you that in order to avoid the contact described above, we have updated the battery fitting procedure and in particular that of the ABS negative cable; it is necessary to connect the <b>ABS negative cable (A)</b> orienting it towards the ignition switch as shown in the figure:</p> <div style="display: flex; justify-content: space-around;">

</div> <p>We ask you to follow the new battery fitting procedure during pre-delivery operations and in any case to always check that the battery is fitted correctly the first time the motorcycle is brought to the workshop. <u>This new battery mounting procedure cancels and replaces the information contained in the model introduction bulletin SRV-SRB-20-002.</u></p>

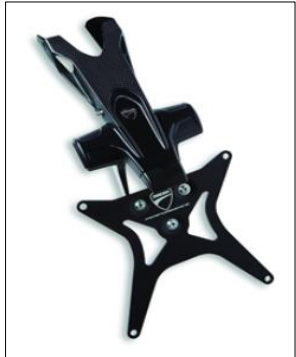
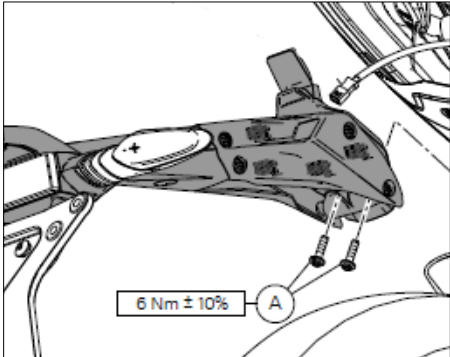
8	Precautions for the assembly of Ducati Performance carbon number plate holder kit part no. 97381161CA	Ducati Performance carbon number plate holder kit part no. 97381161CA

<p>When assembling the Ducati Performance carbon number plate holder unit part no. 97381161CA, we remind you to always apply <b>LOCTITE 243</b> on the threads of the <b>2 screws (A)</b> for fixing the unit to the rear subframe and tighten them to the specified torque of <b>6 Nm ± 10%</b> as indicated in the relevant instructions.</p>
