<b>HYUNDAI</b> <b>Technical Service Bulletin</b>	GROUP	NUMBER
	<b>CAMPAIGN</b>	<b>21-01-053H</b>
	DATE	MODEL(S)
	<b>JUNE, 2020</b>	<b>SANTA FE HYBRID (TM HEV)</b>
<b>SUBJECT:</b>	<b>INSTRUMENT CLUSTER SOFTWARE UPDATE  (SERVICE CAMPAIGN T6T)</b>

**Applicable Vehicle: Certain 2021MY Santa Fe Hybrid (TM HEV)**

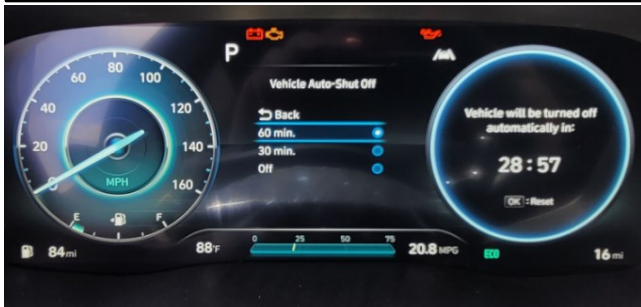
Example display of Display Audio system

**Description:** Some 2021 Santa Fe Hybrid (TM HEV) vehicles may exhibit the Auto-Shut Off incorrect clock countdown displayed on the instrument cluster. If the user selects 60 minutes, the countdown clock will start at 29:59 instead of 59:59. This bulletin provides the service procedure to update the instrument cluster software to correct the Auto-Shut Off countdown clock.

Incorrect Auto-Shut Off Countdown
