HYUNDAI Technical Service Bulletin

GROUP Body	NUMBER 21-BD-003H
DATE June, 2021	MODEL(S) Palisade (LX2)

SUBJECT: WIND/WHISTLING NOISE FROM DOOR GLASS AREA

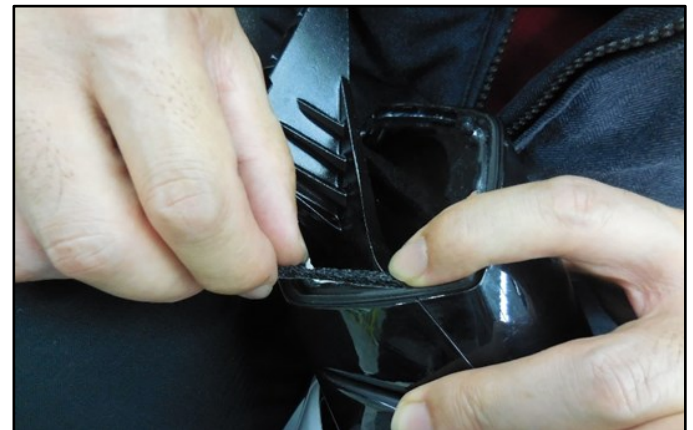
The pad must not extend beyond the edge of the side view mirror seal.

3. Attach the pad to the side view mirror seal.

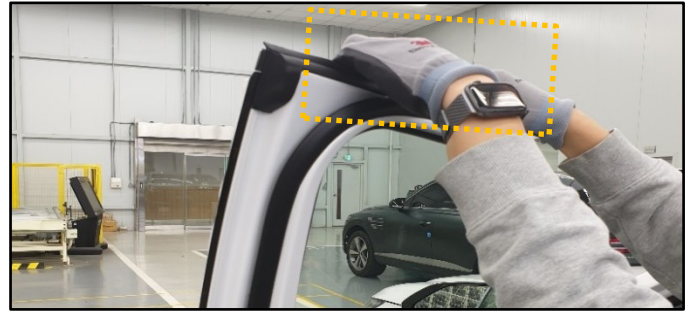
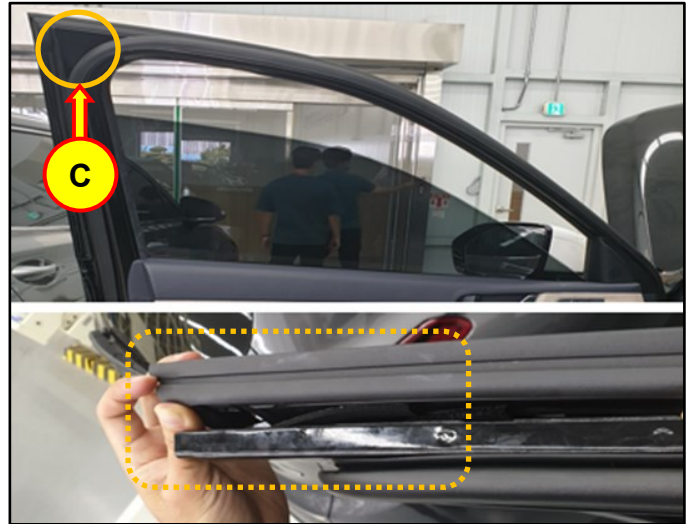
Do not completely remove the glass run.

1. Remove the top corner of the front door glass run (C).

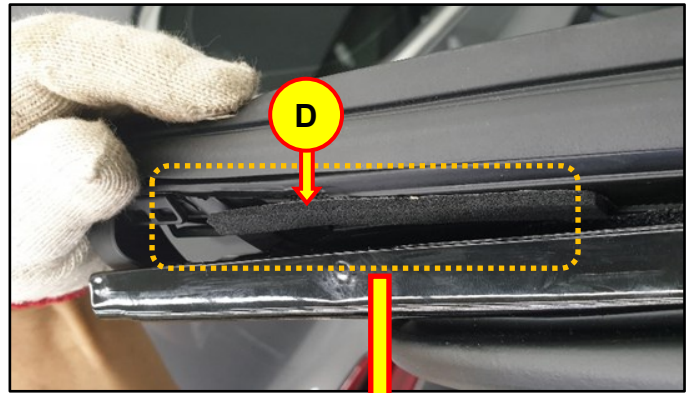
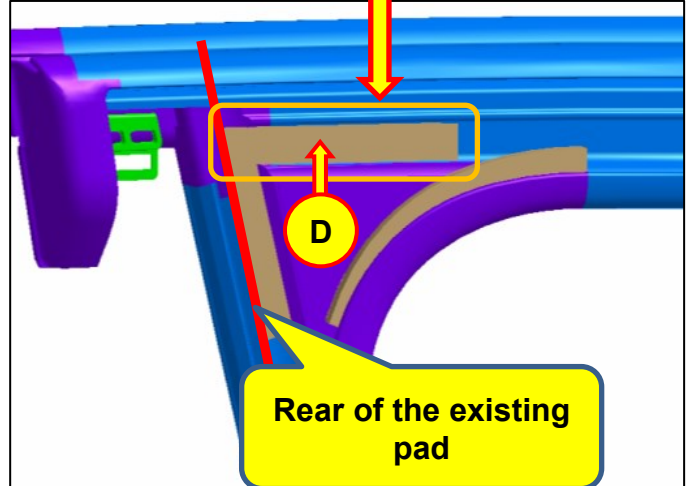
Attach the glass run pad directly onto the existing pad.

Align the glass run pad to the rear of the existing pad.

2. Attach the glass run pad (D) as shown in the photos.
