<b>HYUNDAI</b> <b>Technical Service Bulletin</b>	GROUP <b>Engine Mechanical</b>	NUMBER <b>21-EM-007H</b>
	DATE <b>June, 2021</b>	MODEL(S) <b>Sonata Hybrid (LF HEV), Sonata Plug-In Hybrid (LF PHEV)</b>
<b>SUBJECT:</b>	<b>DTC P2600 ENGINE ELECTRIC WATER PUMP DIAGNOSIS AND REPAIR GUIDELINE</b>

**Description:** This bulletin describes the procedure to diagnose and repair the Engine Electric Water Pump (EEWP) on certain Sonata Hybrid (LF HEV) and Sonata Plug-In Hybrid (LF PHEV) vehicles with DTC P2600, causing an HEV and/or MIL warning lamp illumination.

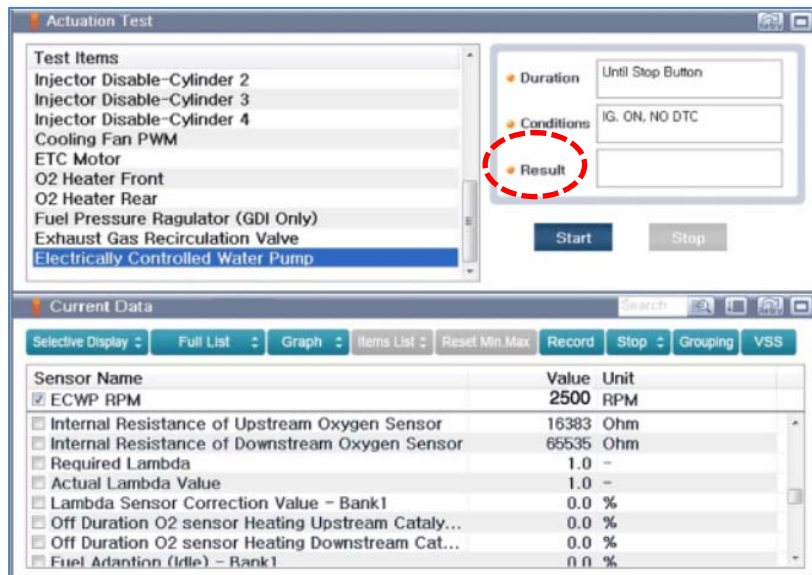
1. Confirm that there are sufficient coolant levels in the Engine Coolant Reservoir.
  - If coolant levels are low, check for leaks and repair as needed.
2. Turn on the engine.
3. Connect GDS and clear all related DTC's.
4. Use GDS and force activate the EEWP with an actuation test.

GDS-M will display "Operation Command Sent" if the ECU accepted the request to operate the component.

- If EEWP fails to operate when commanded ON with the GDS Actuation Test, check connectors for loose connections.
    - While EEWP is commanded ON, apply a wiggling motion on the connections to confirm wiring connections and pins are not damaged. Repair as needed.
5. Make note of any DTCs that set or failed operation and listen for the EEWP making noise.
    - If EEWP State displays a Fault Code, then replace the EEWP.
    - If EEWP State displays a Protection Code, check voltage on auxiliary battery.
      - An EEWP static pressure related DTC may be generated in case of abnormal auxiliary battery voltage.
